HIGH-LEVEL TACTILE INSPECTIONS

SAMPLING PHASE 1
REPORT
Crichton Castle
PIC135

Title:	High-Level Tactile Sample Inspection Project Phase 1 Report PIC135 Crichton Castle
Authors:	[REDACTED]
Document created:	September 2021
Reviewed by:	[REDACTED]
Date Reviewed:	17/09/2021
Approved by:	[REDACTED]
Date of Approval:	17/09/2021
Version Number:	V0100

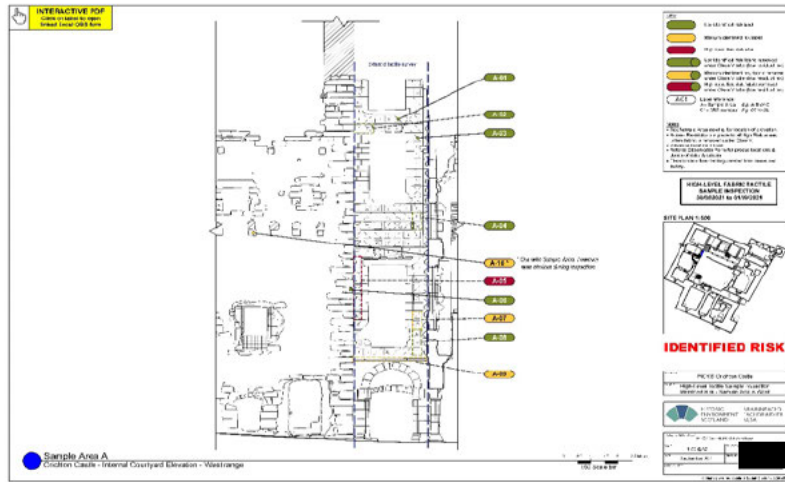
[PIC135-HLR-SI-A-West](#)

Numerous diamond facets were found to be boss, delaminating or cracked indicating a likelihood of fabric fall in the future.

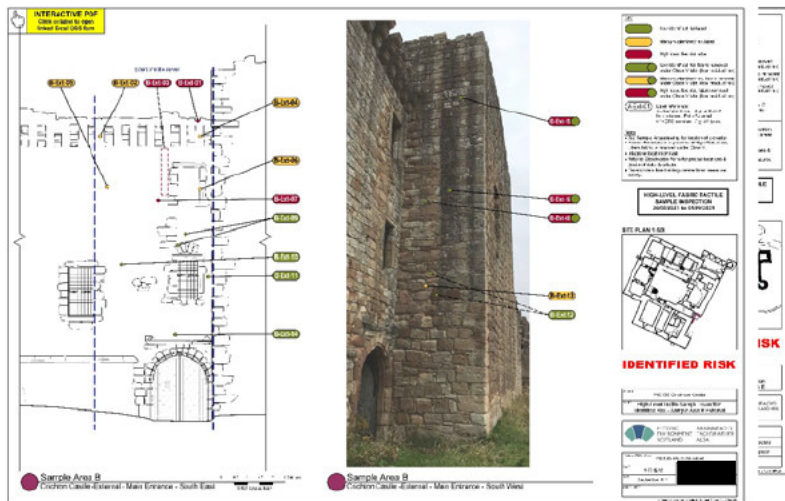
[PIC135-HLR-SI-B-Ext](#)

- External: Stone surface scaling and localised mortar decay with a subsequent risk of hard cement pointing falling. A number of loose stone fragments were found on the wall head.

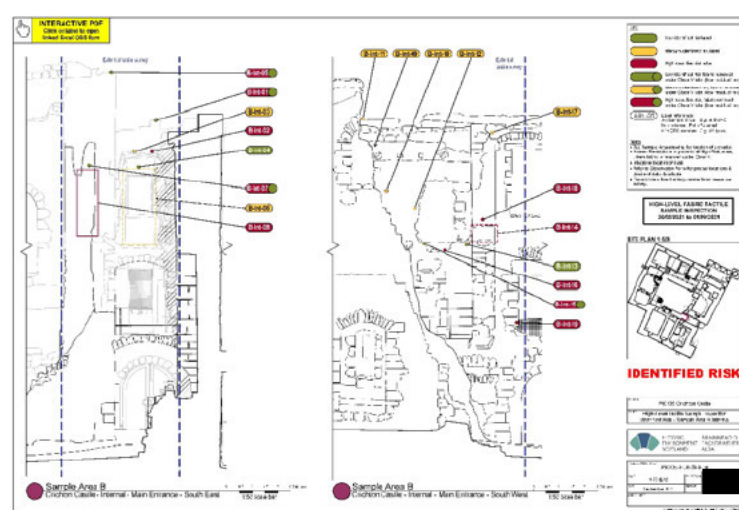
[PIC135-HLR-SI-B-INT](#)

- Internal: Loose stone fragments, loose pinnings and loose render at high risk of fall over large surface areas. Advice was sought from Structural Engineer in relation to the safety of soffit stones with little or no obvious support above the entrance area. The restricted internal entrance into the castle presents a risk of severe injury/to life to persons below.
