High Level Masonry Project  
Tactile safety inspection of high-level fabric

REPORT  
Inverlochy Castle  
PIC075

December 2022

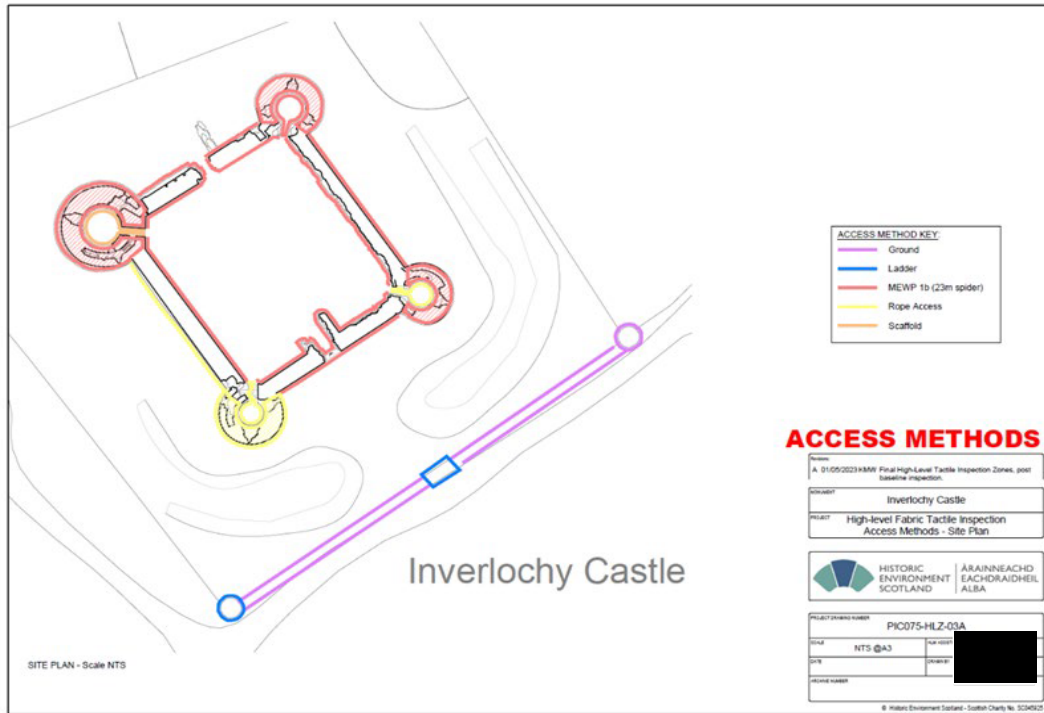
[PIC075-HLZ-03A](#)

| <b>Limitations of inspection:</b> | <p>Zone 3 access restriction removed after consultation with Region and Heritage</p> <p>- Partial insptions carried out at Zones 4,5,10,12,16,17 due to loose masonry on wall head level</p> |

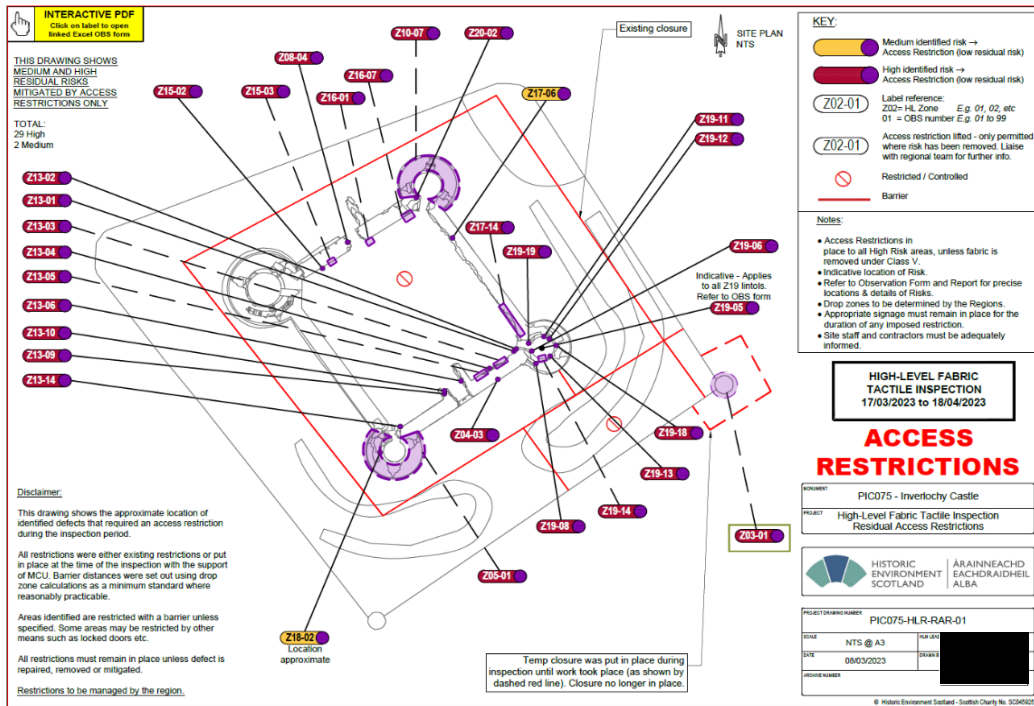
PIC075-HLR-RAR-01

- Loose masonry on wall heads. Although site is closed secure fencing has been breached on a few occasions by teenagers. More robust fencing will be required as discussed with Regional Management: Link below in "Linked Drawings" section.
