# MONUMENT MANAGEMENT FUND 2023-24

Heritage Directorate

August 2024

HISTORIC  
ENVIRONMENT  
SCOTLAND

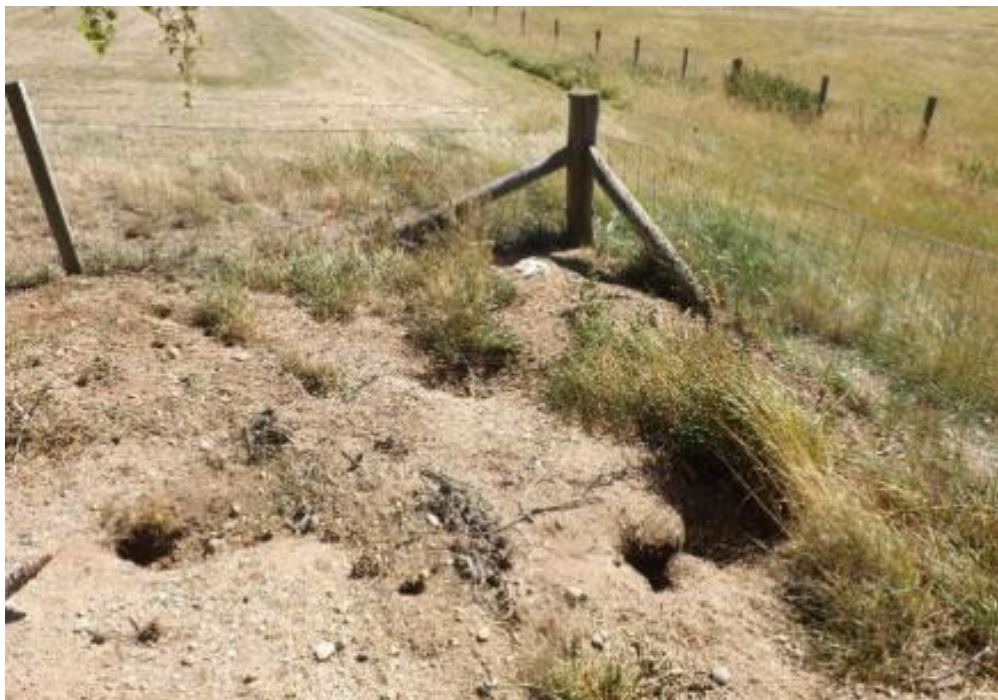
The works should significantly reduce the rabbit population living on the scheduled area and prevent their re-invasion in the future. It will also prevent stock getting onto the site and causing further damage when rabbit burrows collapse under them.

**Figure 3: Rabbit burrows and old fence around the souterrain prior to commencement of works**

A rabbit and stock proof fence has been erected around the perimeter of the scheduled area and rabbit boxes have been inserted underneath it. The old fence around the souterrain, which was located within the scheduled area, has been taken down and removed.

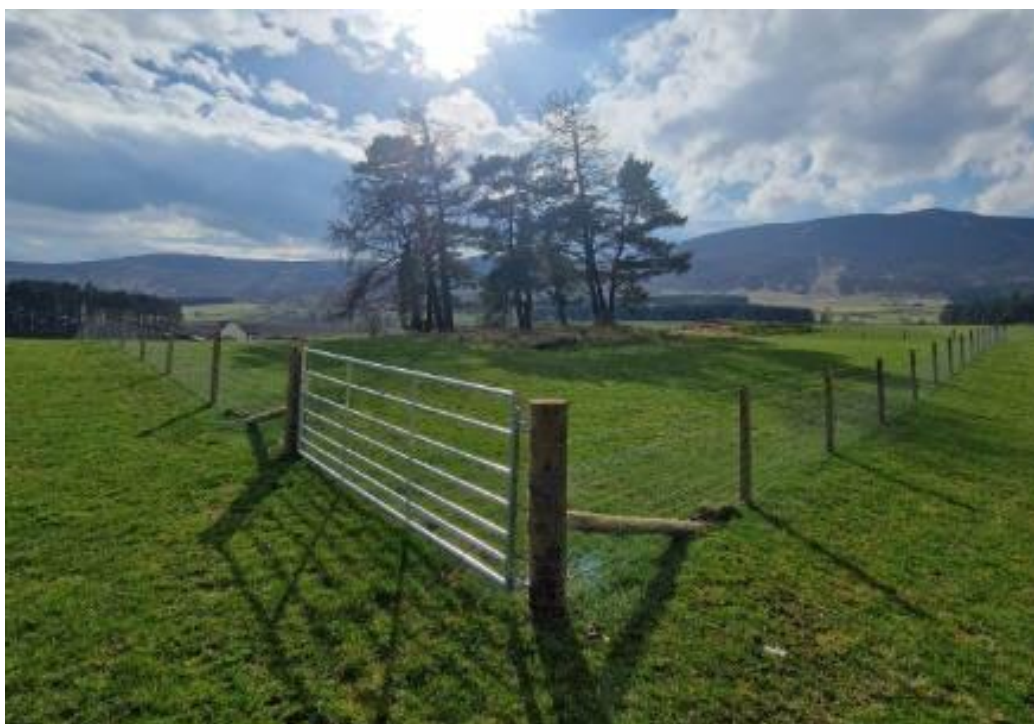
**Figure 4 New rabbit proof fence installed around perimeter of the scheduled area**

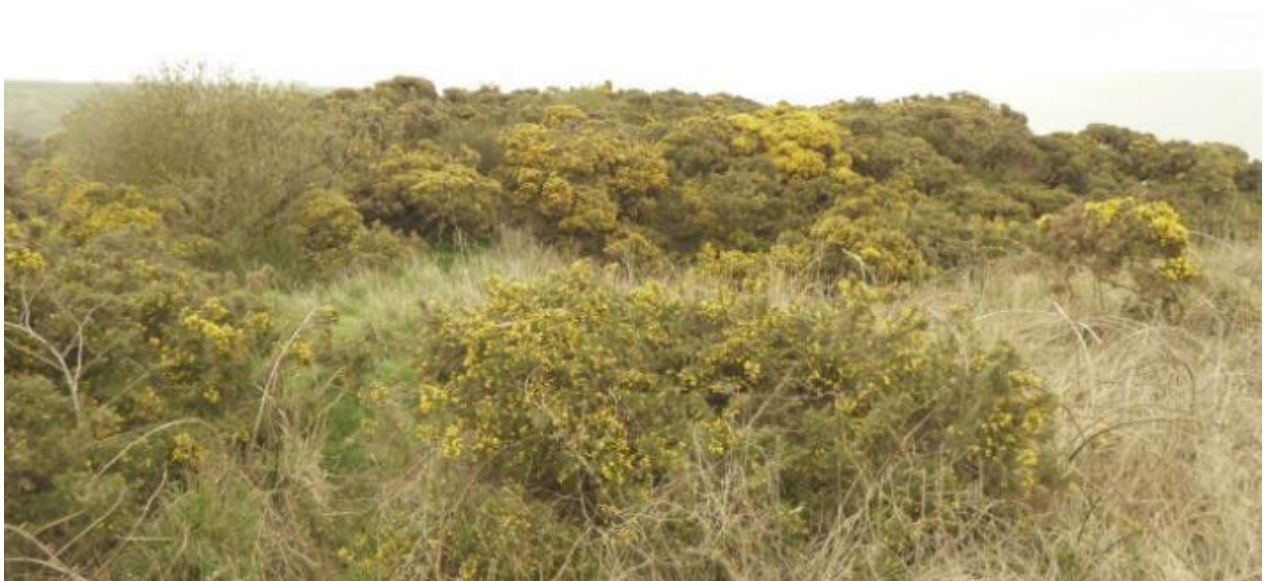
The risk of deterioration of the archaeological remains due to scrub growth has been reduced. It will also reduce the risk of rabbit burrowing under the dense cover the gorse provided. It also allows appreciation of the form of the monument.

Figure 5 View of the monument prior to works taking place, covered in gorse

Clearance of gorse, which was entirely obscuring this promontory fort.

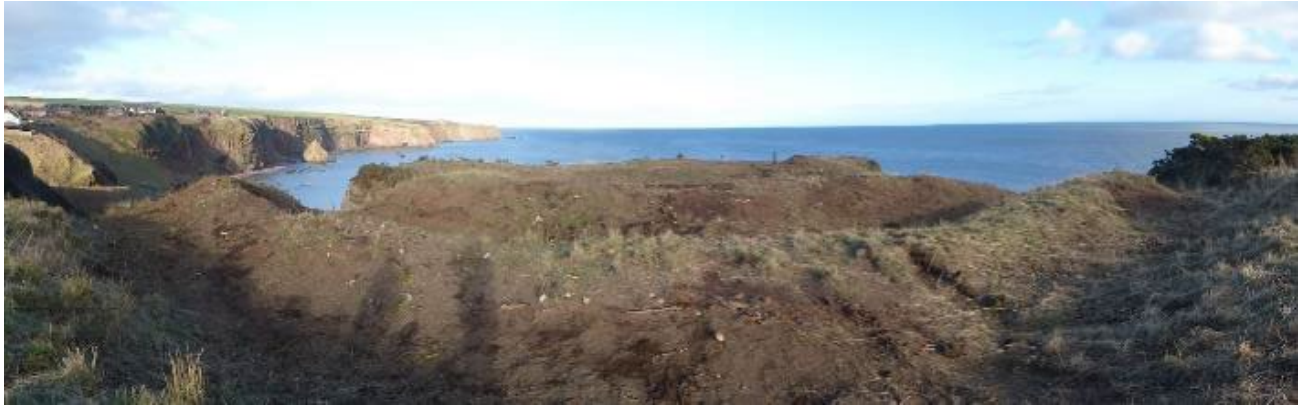
**Figure 6 A view of the fort after gorse clearance**

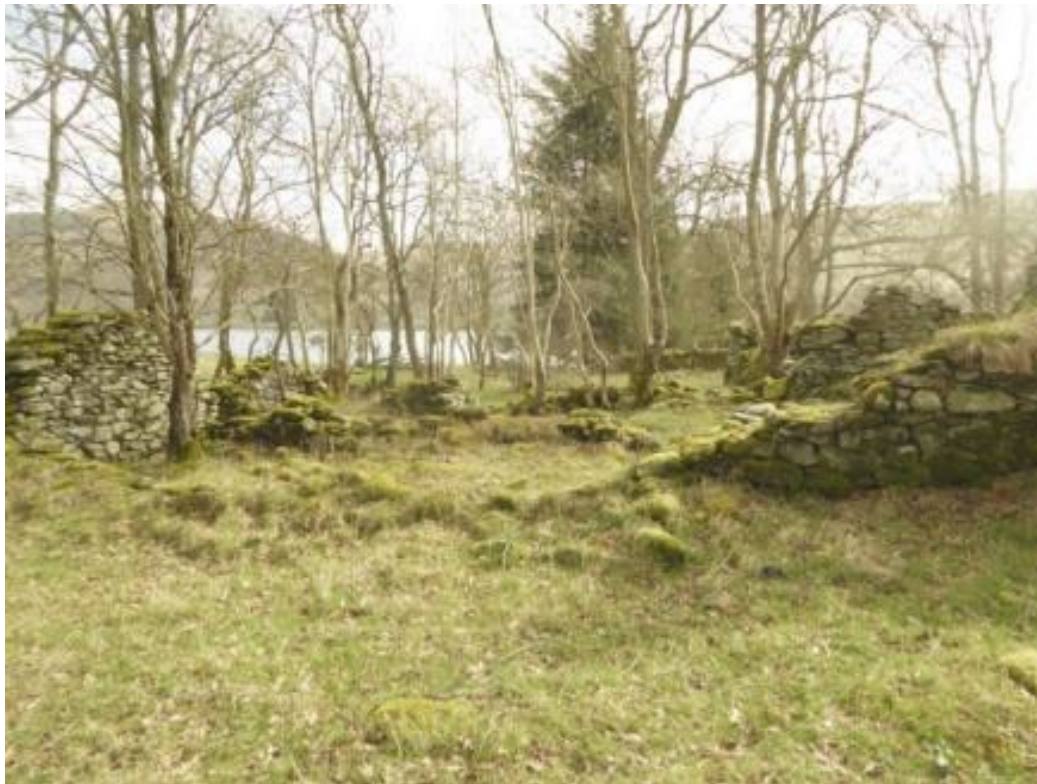
These works will reduce the risk of damage to building remains through impact damage from branches and root growth. It also allows greater appreciation of the village layout and buildings.

Figure 7 View of the building remains prior to works commencing

Overhanging branches and saplings growing on wall heads have been cut down. Stumps have been treated to prevent regrowth.

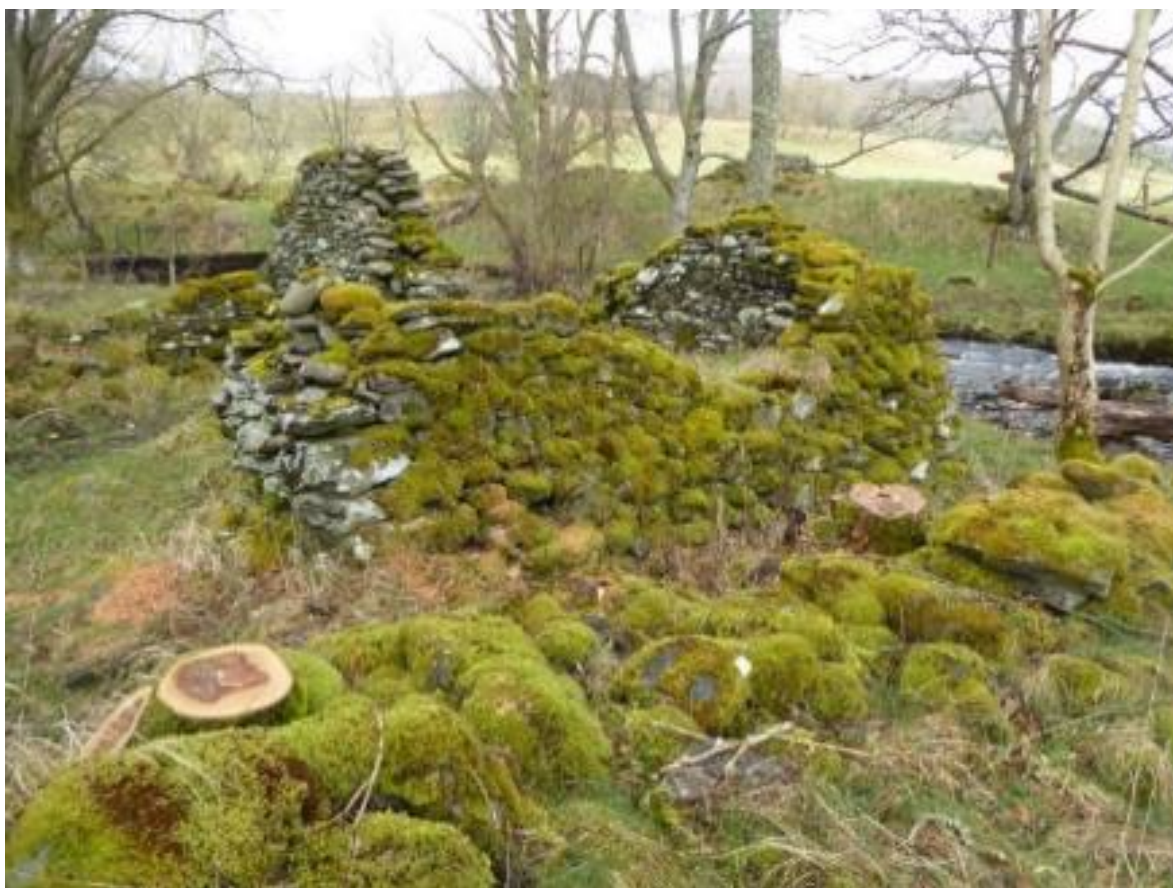
Figure 8 View of the monument with trees removed and stumps treated

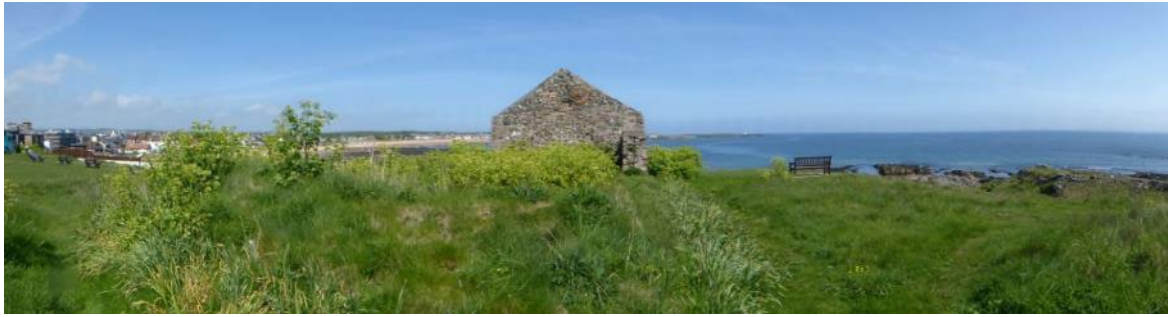
**Figure 9 View of the Chapel prior to strimming – with *Smyrnium olustratum* visible in the foreground**

The area around the chapel has been strimmed to help control an invasion of *Smyrnum olustratum* (Alexanders).

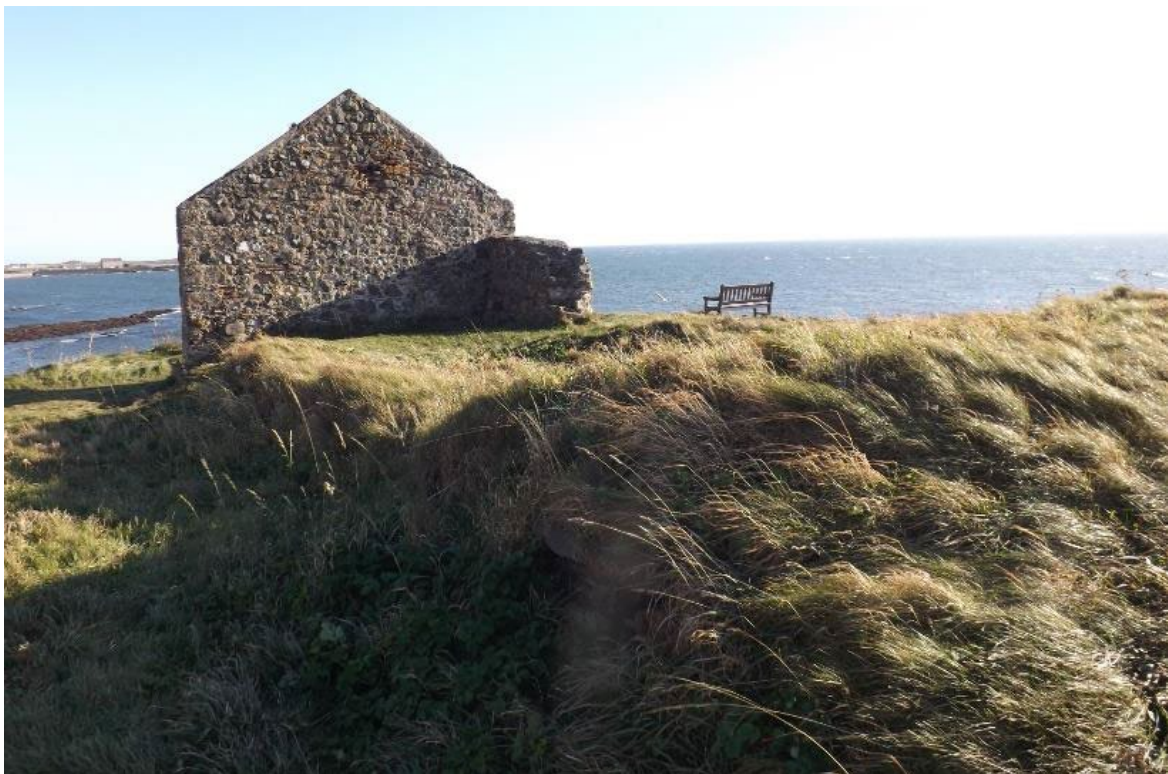
**Figure 10 View of the chapel after strimming**

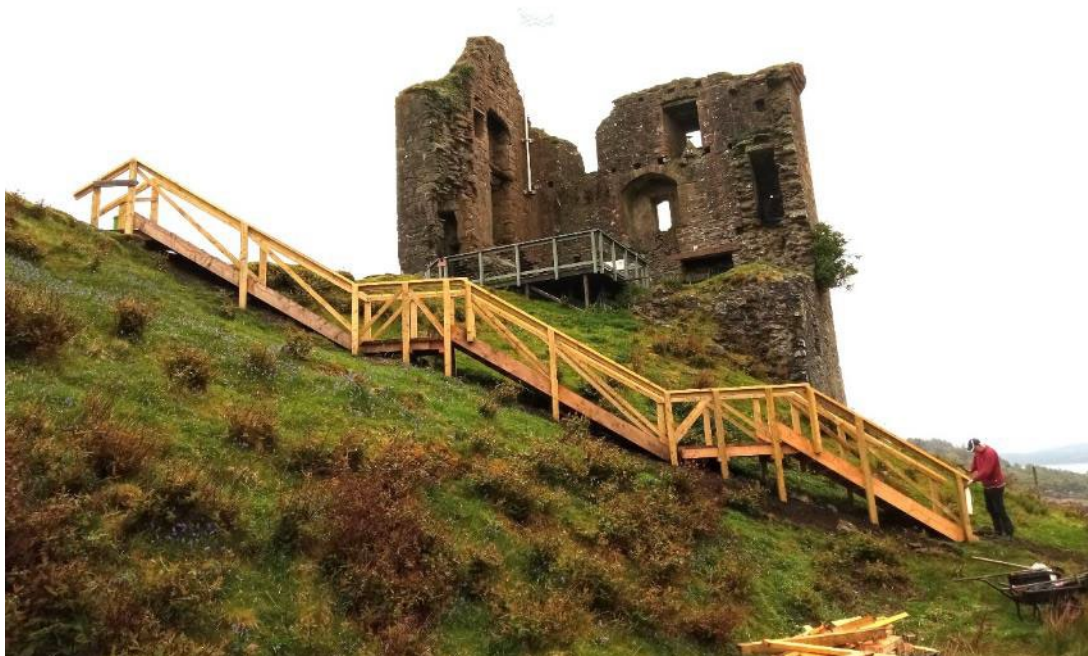
**Figure 11** Maintenance of pathways and stairs to allow public access to the monument

Support for the Trust's small herd of sheep which maintains the castle under an ideal cover of short-cropped grass. The work also includes maintenance of stairs, picnic tables and shelters through weather-proofing and wood treatment, with significant in-kind contribution in volunteer hours.

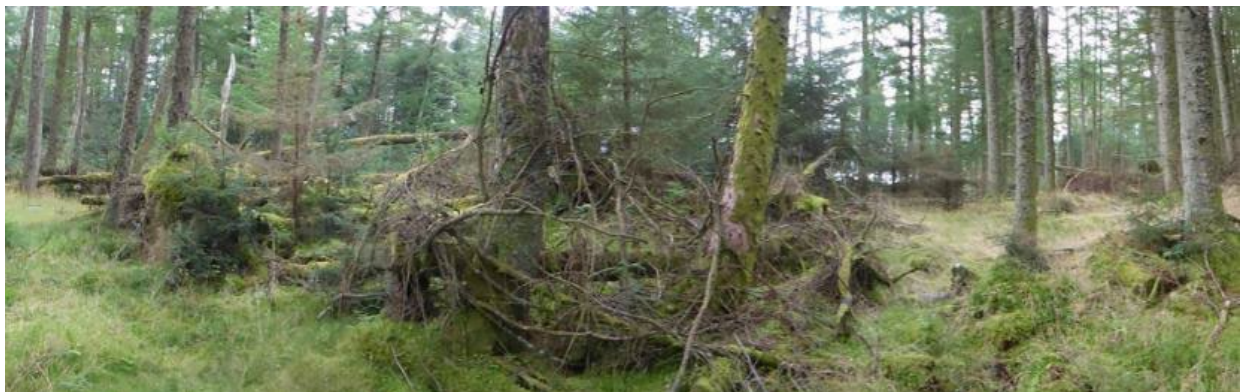
This monument has suffered significant wind blow damage over the last 10 years, with large root plates uplifted from the body of the cairn. It was at risk from further wind blow damage as many trees remained. These works have removed that risk entirely.

Figure 12 Windblown trees on the chambered cairn prior to commencement of works

All trees growing on the chambered cairn have been sectionally felled and removed to the edge of the scheduled area. In addition, a large number of wind blown trees were also cut up and disposed of. In total approx. 120 mature conifers have been removed.

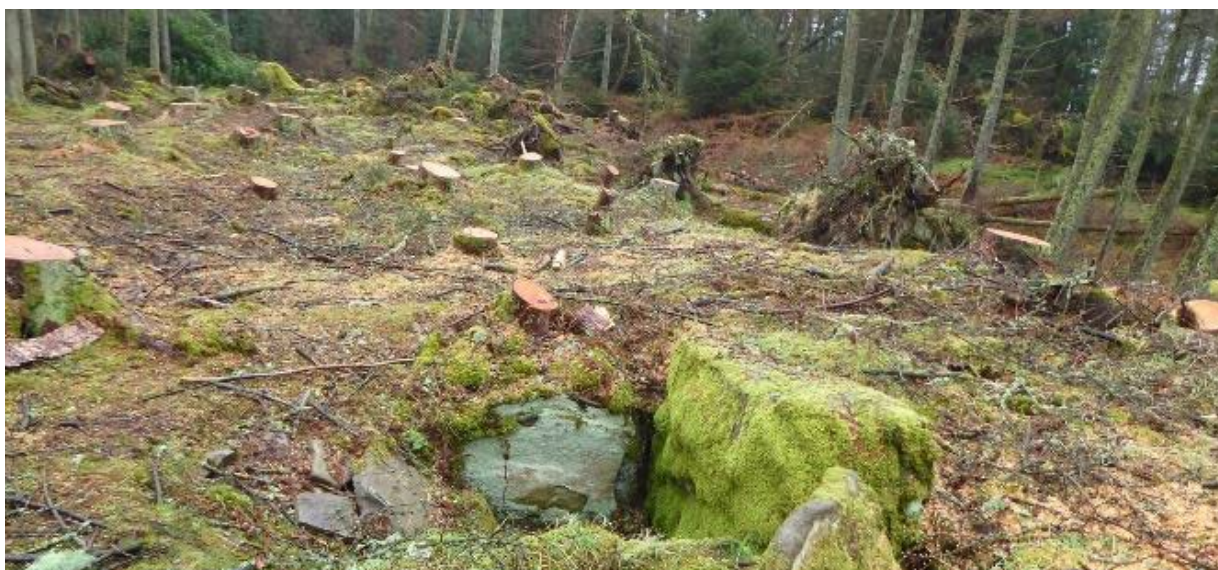
**Figure 13** The chambered cairn after tree removal

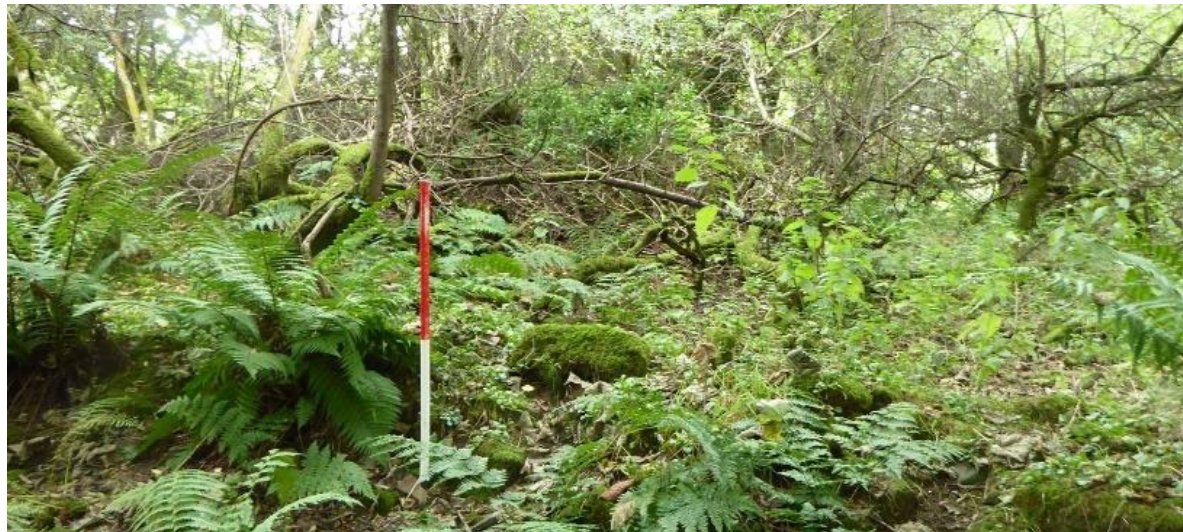
**Figure 14** View of the overgrown fort prior to commencement of works

Clearance of scrub, saplings, overhanging and fallen trees from the fort. Much of the interior of the fort was obscured by a large fallen tree. All arisings have been removed from the scheduled area. Stump treatment has been carried out to prevent regrowth.

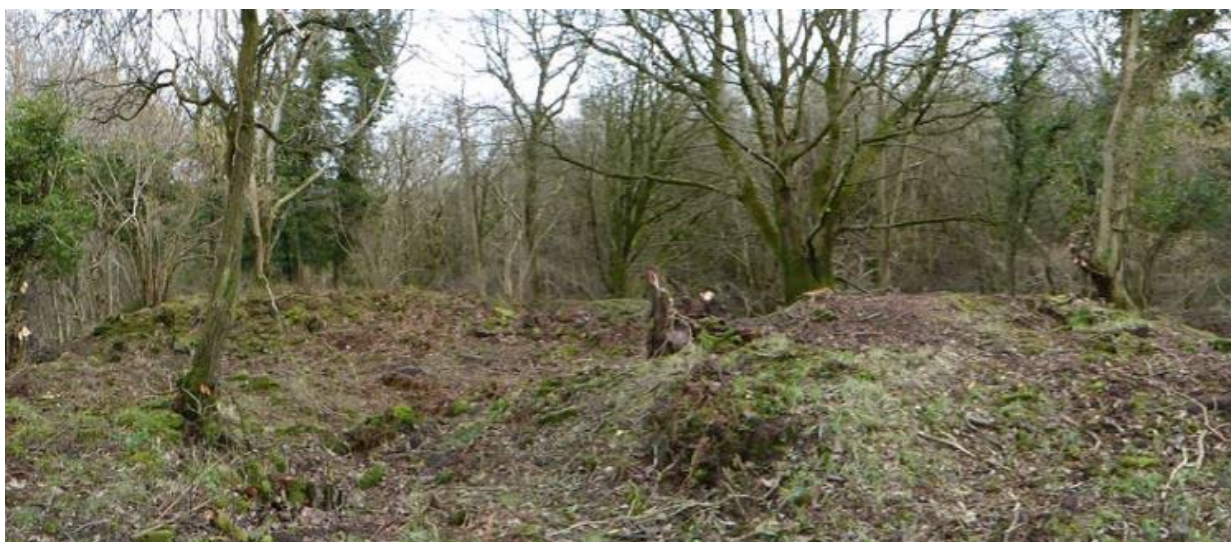
**Figure 15** Remains of the fort after scrub clearance

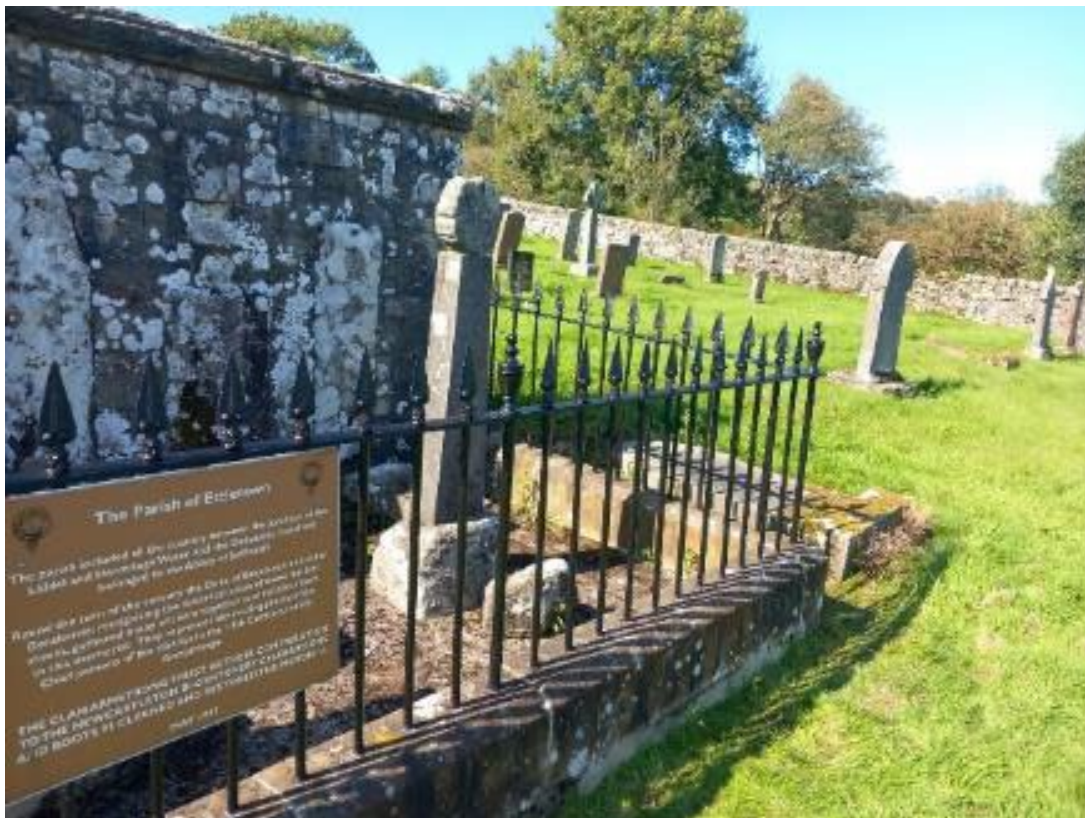
Figure 16 Completed works showing the repaired enclosure

Repointing of wall coping and repair of broken iron railings at the carved stone enclosure in Ettleton Cemetery
