HIGH-LEVEL TACTILE INSPECTIONS

SAMPLING PHASE 1
REPORT
Dirleton Castle
PIC139

Title:	High-Level Tactile Sample Inspection Project Phase 1 Report PIC139 Dirleton Castle
Authors:	[REDACTED]
Document created:	August 2021
Reviewed by:	[REDACTED]
Date Reviewed:	27/08/2021
Approved by:	[REDACTED]
Date of Approval:	30/08/2021
Version Number:	V0100

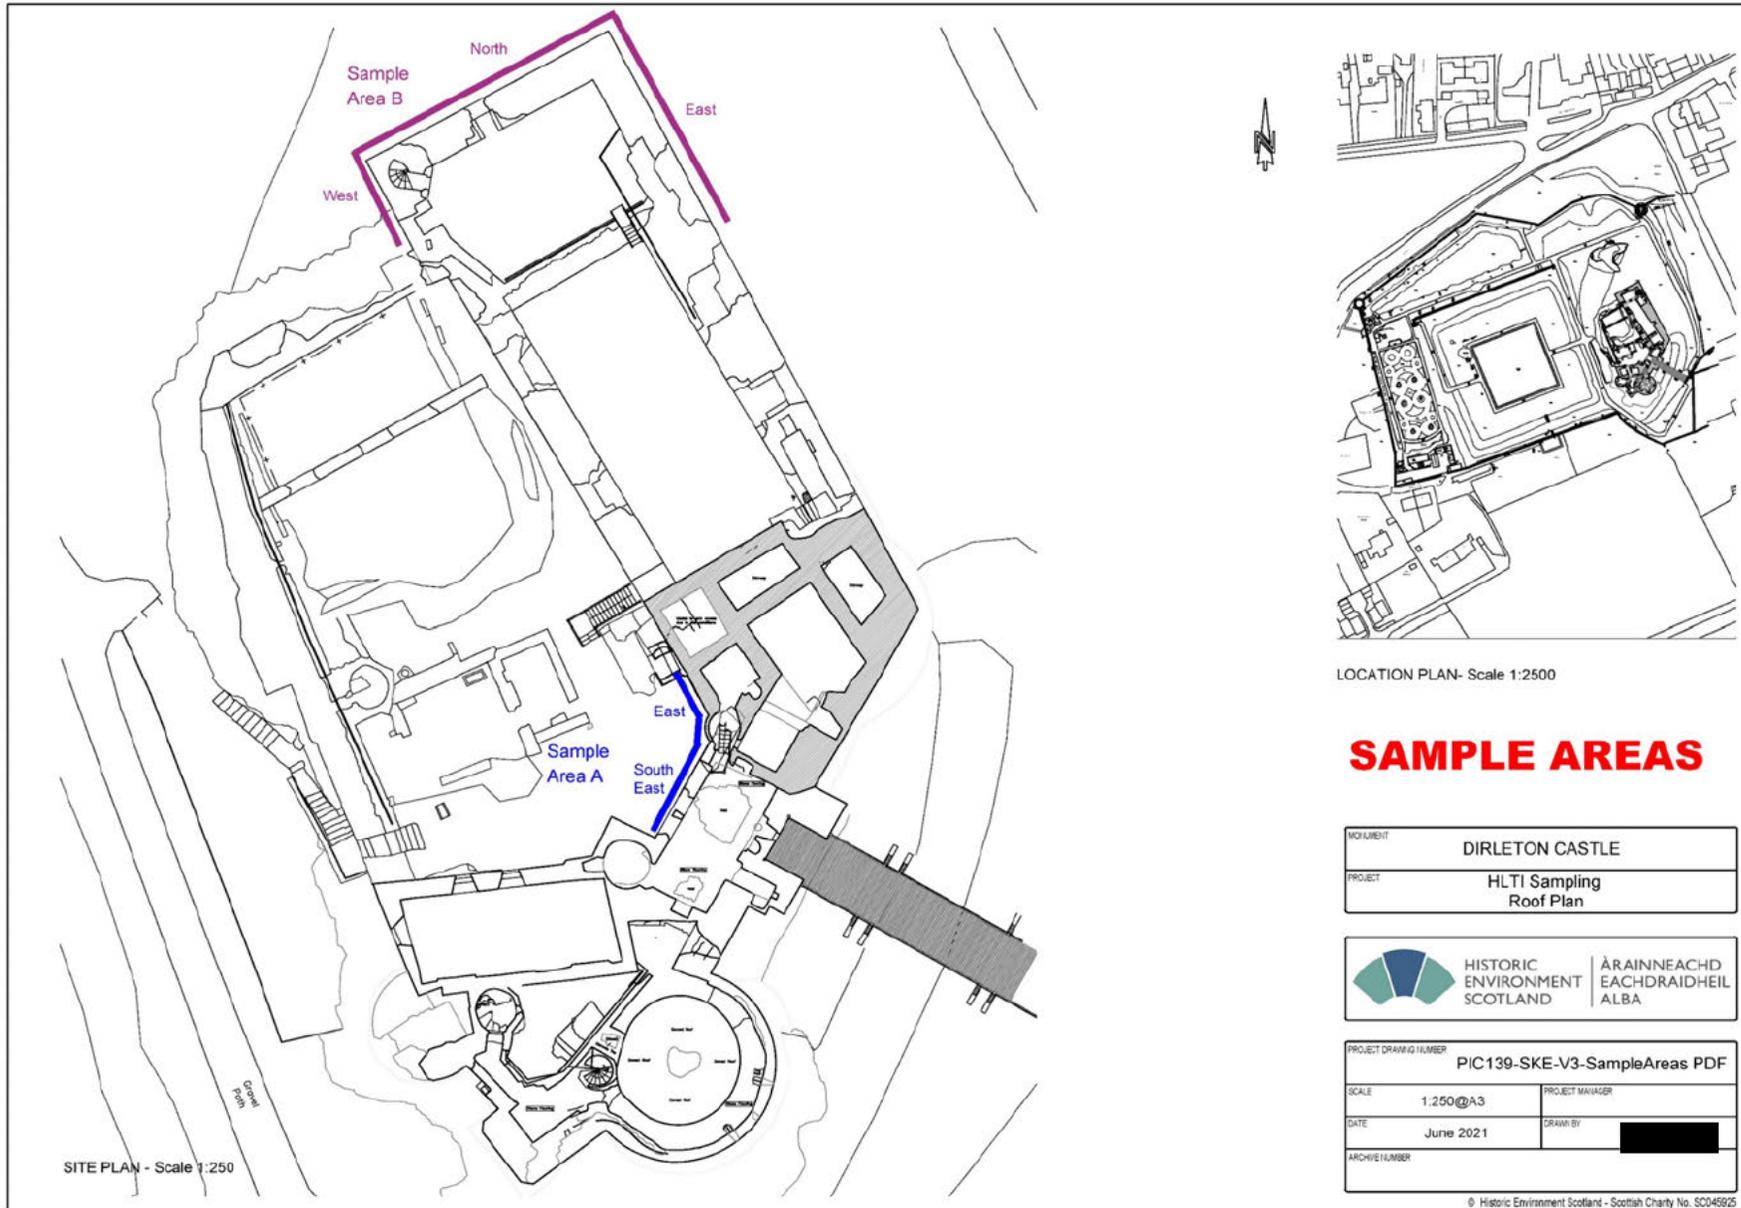
Click on link to open drawing in PDF viewer: [PIC139-SKE-V3-SampleAreas.pdf](#)

Tactile inspections of two sample areas, the internal elevation of the Halyburton Range and Gatehouse (Sample Area A) and the exterior northern end of the Halyburton Range (Sample Area B), were undertaken from an alloy tower and MEWP respectively.

<i>Area:</i>	<i>Colour:</i>	<i>Sample Area Name:</i>
A		Internal elevation of Halyburton Range & Gatehouse
B		North end of Halyburton Range
