HIGH-LEVEL TACTILE INSPECTIONS

SAMPLING PHASE 1
REPORT
Bothwell Castle
PIC114

Title:	High-Level Tactile Sample Inspection Project Phase 1 Report PIC114 Bothwell Castle
Authors:	[REDACTED]
Document created:	September 2021
Reviewed by:	[REDACTED]
Date Reviewed:	17/09/2021
Approved by:	[REDACTED]
Date of Approval:	17/09/2021
Version Number:	V0100

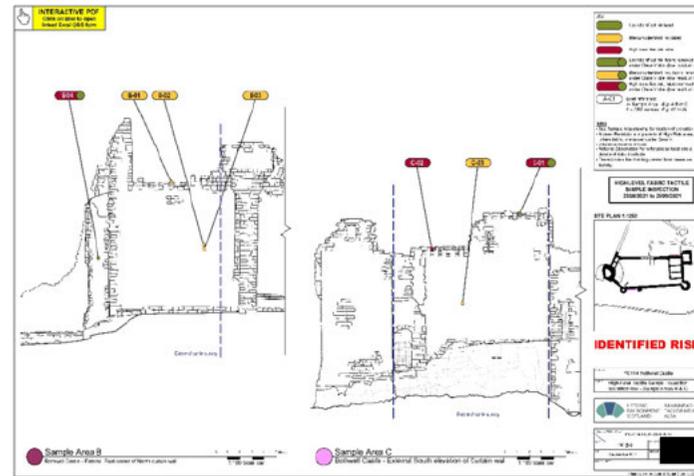
Sample Areas B & C

Sizeable loose stones were found in the upper section of the South curtain wall and the risks identified in this area have been communicated promptly to the District Architect and MCU to allow suitable action to be taken to maintain health and safety.
