HIGH-LEVEL TACTILE INSPECTIONS

SAMPLING PHASE 1
REPORT
Dundonald Castle
PIC194

Title:	High-Level Tactile Sample Inspection Project Phase 1 Report PIC194 Dundonald Castle
Authors:	[REDACTED]
Document created:	August 2021
Reviewed by:	[REDACTED]
Date Reviewed:	27/08/2021
Approved by:	[REDACTED]
Date of Approval:	30/08/2021
Version Number:	V0100

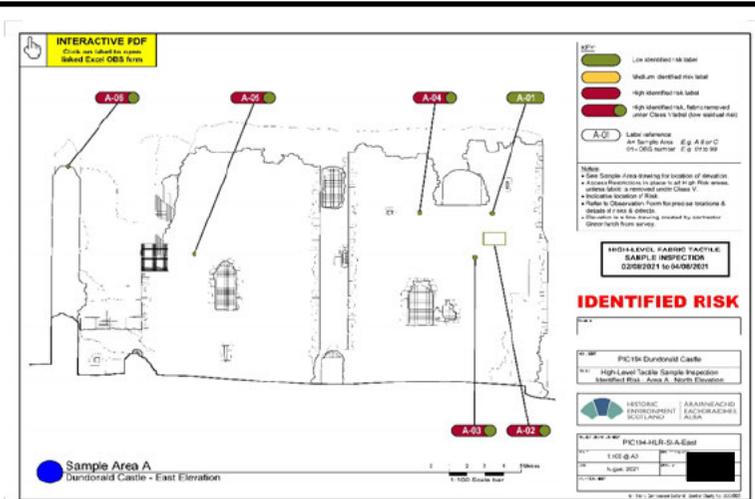
Sample Area A

The South wall (inspection area B) wall head is rough raked but tightly pointed. The main cause of fabric risk was a result of localised mortar decay which in a few instances resulted in loose pinning on the East elevation and a few loose wall head stones/large pinnings on the South elevation. Due to known unauthorised ingress of the site and walls, loose stones were removed as a safety precaution as all of them had the potential to kill, due to the height of their location, the hardness, weight and sharp cornered shapes of the stones. A separate Class V report and notification has been issued.
