HIGH-LEVEL TACTILE INSPECTIONS

SAMPLING PHASE 1
REPORT
Linlithgow Palace
PIC155

Title:	High-Level Tactile Sample Inspection Project Phase 1 Report PIC155 Linlithgow Palace
Authors:	[REDACTED]
Document created:	September 2021
Reviewed by:	[REDACTED]
Date Reviewed:	30.09.2021
Approved by:	[REDACTED]
Date of Approval:	30.09.2021
Version Number:	V0100

PIC ID # ↓	PIC155	Site name	Linlithgow Palace, Peel & Park		
Inspection start	06/09/2021	Inspection end	09/09/2021	Submission	30/09/2021
Lead HBFA	[REDACTED]				
Sample Inspectors	[REDACTED]

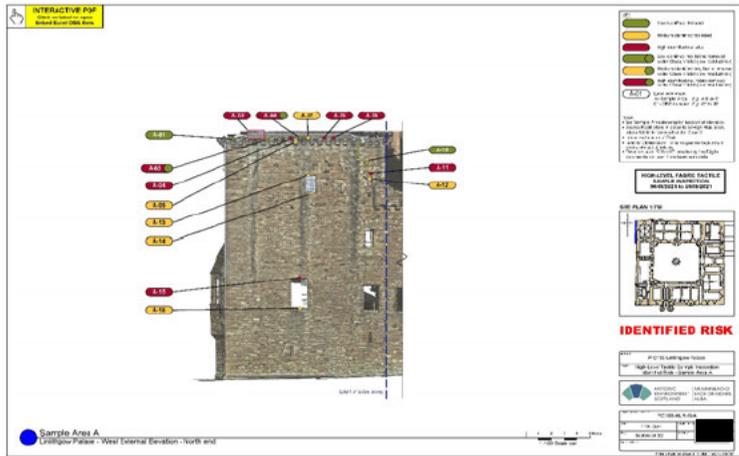
Sample Area A

Sample Area A: West elevation - North end

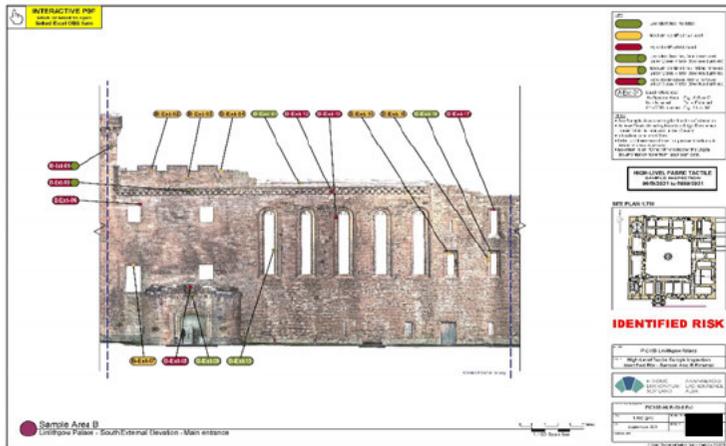
Sample Area B

Sample Area B: South wall - Main entrance to staff entrance (externally) and main entrance area internally

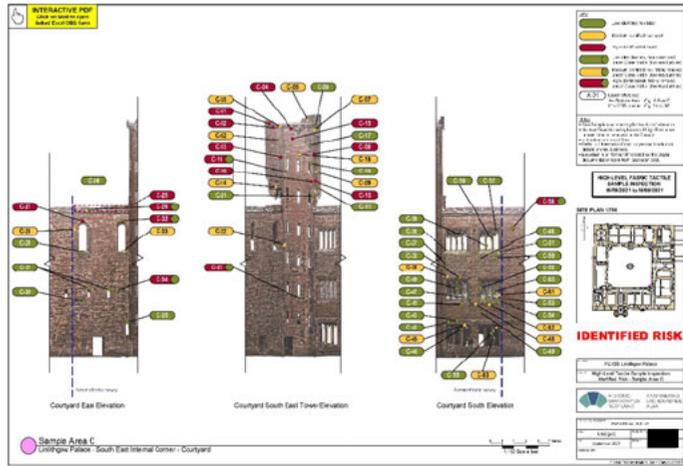
Sample Area C

Sample Area C: Internal South east corner of courtyard including Southeast tower staff entrance

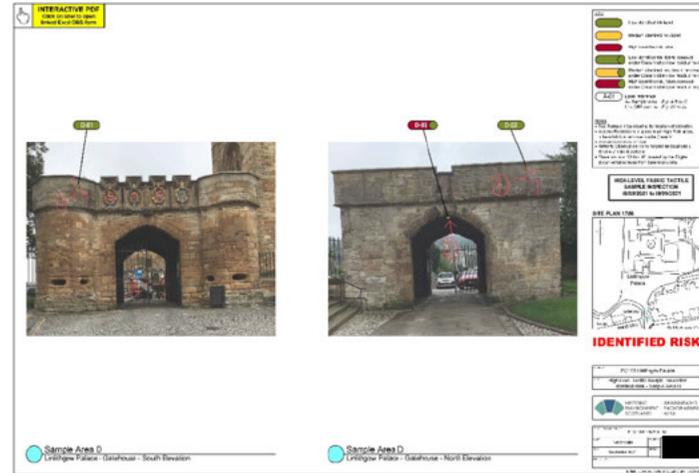
Sample Area D

Sample Area D: Gatehouse
