HIGH-LEVEL TACTILE INSPECTIONS

SAMPLING PHASE 1
REPORT
MacLellan's Castle
PIC204

Title:	High-Level Tactile Sample Inspection Project Phase 1 Report PIC204 MacLellan's Castle
Authors:	[REDACTED]
Document created:	August 2021
Reviewed by:	[REDACTED]
Date Reviewed:	07/09/2021
Approved by:	[REDACTED]
Date of Approval:	17/09/2021
Version Number:	V0100

PIC ID # ↓	PIC204	Site name	MacLellan's Castle		
Inspection start	16/08/2021	Inspection end	17/08/2021	Submission	17/09/2021
Lead HBFA	[REDACTED]				
Sample Inspectors	[REDACTED]

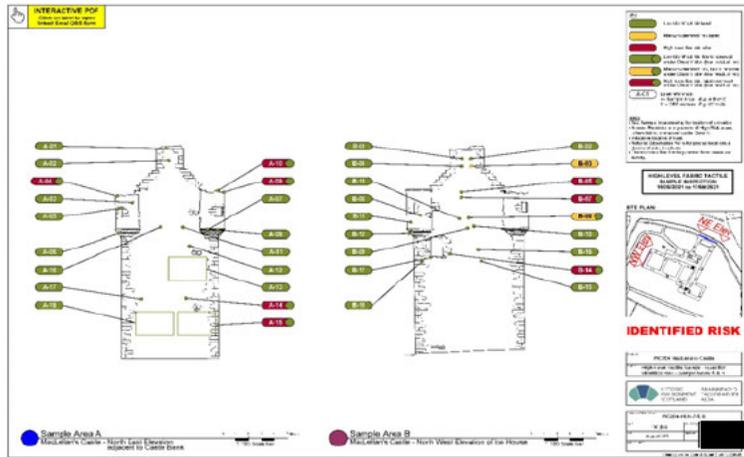
Sample Areas A & B

Substantial stones were found to be loose on the wall head on Sample Area A above the public road and these were removed for safety. These stones were of sufficient size to have the potential to cause major injury or death if they had fallen.

An un-monitored crack was noted travelling vertically from the window opening in Sample Area B and several cracked and decaying lintels were also noted in the Bartizans. These items were notified to the District Architect and HES Engineers, for their information and assessment.
