High Level Masonry Project Tactile safety inspection of high-level fabric

REPORT Lochleven Castle PIC030

November 2022

Title:	Tactile safety inspection of high-level fabric Report PIC030 Lochleven Castle
Authors:

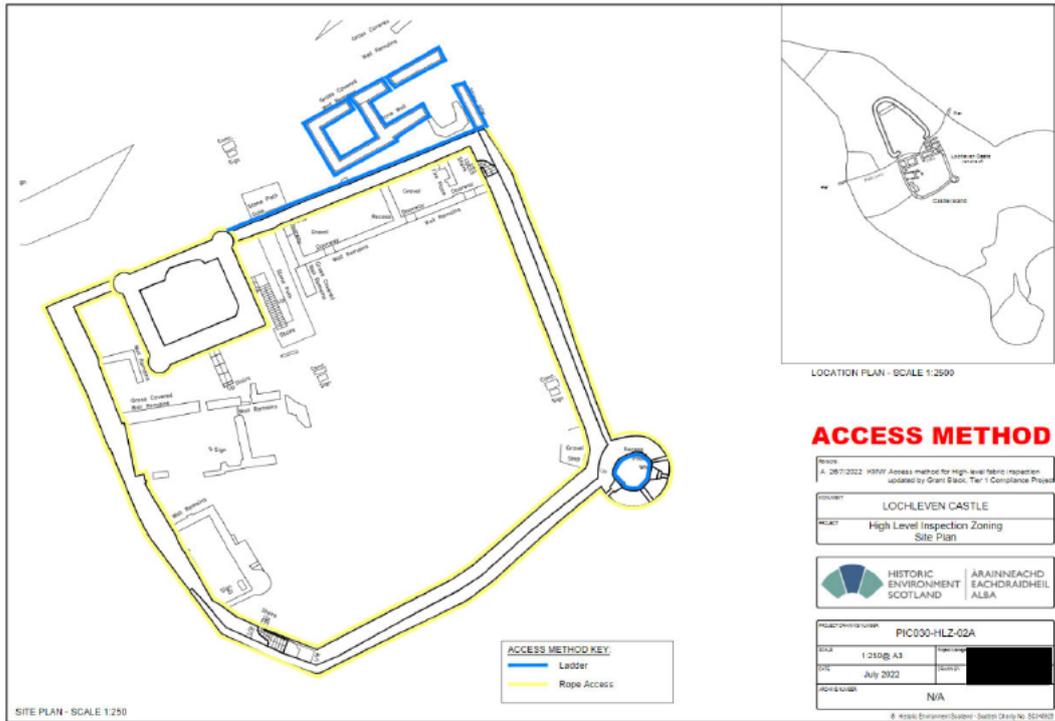
PIC030-HLR-RAR-01 (REV-A)

Z02-01 Access restriction Med - only permitted where risk has been removed.

REV-A: Glassin Tower closure added 30/11/2022

- Access Restrictions in place to all High Risk areas, unless fabric is removed under Class V.
- Indicative location of Risk.
- Refer to Observation Form and Report for precise locations & details of Risks.
- Drop zones to be determined by the Region.
- Appropriate signage must remain in place for the duration of any imposed restriction.
- Site staff and contractors must be adequately informed.
