Tactile safety inspection of high-level fabric

REPORT St Andrews Castle PIC034

July 2022

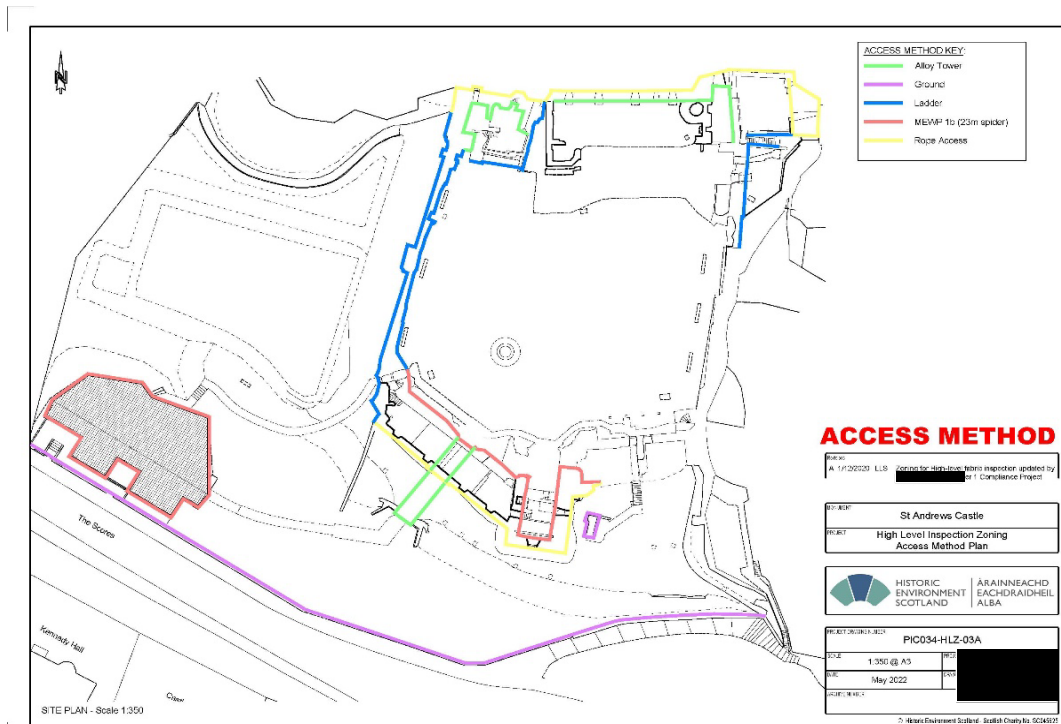
[PIC034-HLZ-03A](#)

Areas not inspected:	Z03 due to nesting birds & Z15 (Visitor Centre) which was not within current scope as it is modern fabric. UPDATE 14/11/2022 Z03 was inspected by a rope access team. No observations found. Z17 added following zone revision - no observations found.
-----------------------------	---
