MONUMENT MANAGEMENT FUND 2023-24

Heritage Directorate

August 2024

HISTORIC
ENVIRONMENT
SCOTLAND

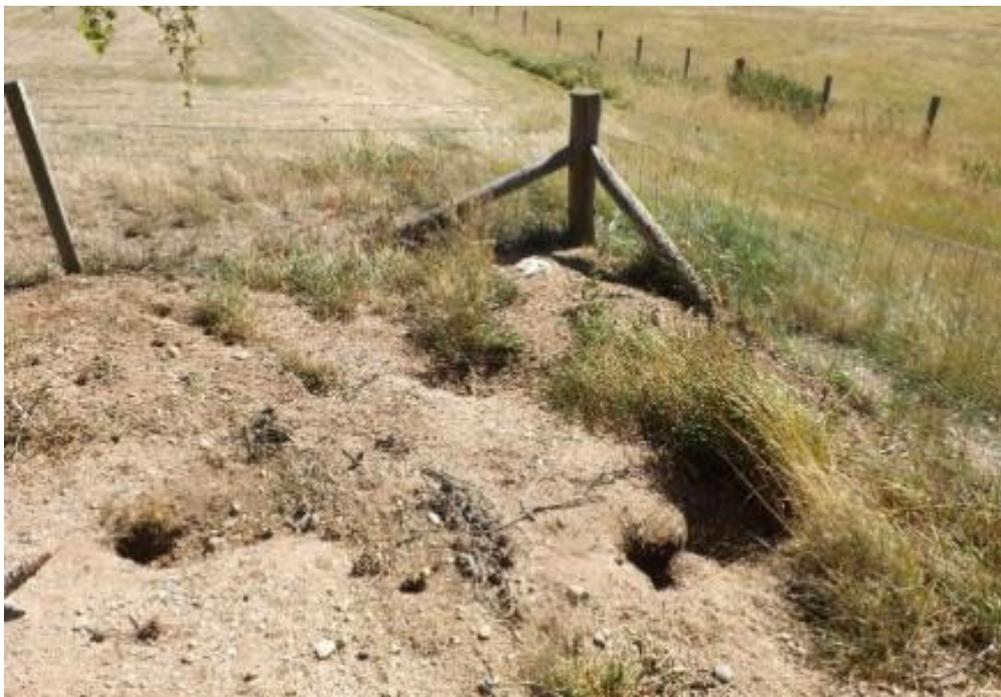
The works should significantly reduce the rabbit population living on the scheduled area and prevent their re-invasion in the future. It will also prevent stock getting onto the site and causing further damage when rabbit burrows collapse under them.

Figure 3: Rabbit burrows and old fence around the souterrain prior to commencement of works

A rabbit and stock proof fence has been erected around the perimeter of the scheduled area and rabbit boxes have been inserted underneath it. The old fence around the souterrain, which was located within the scheduled area, has been taken down and removed.

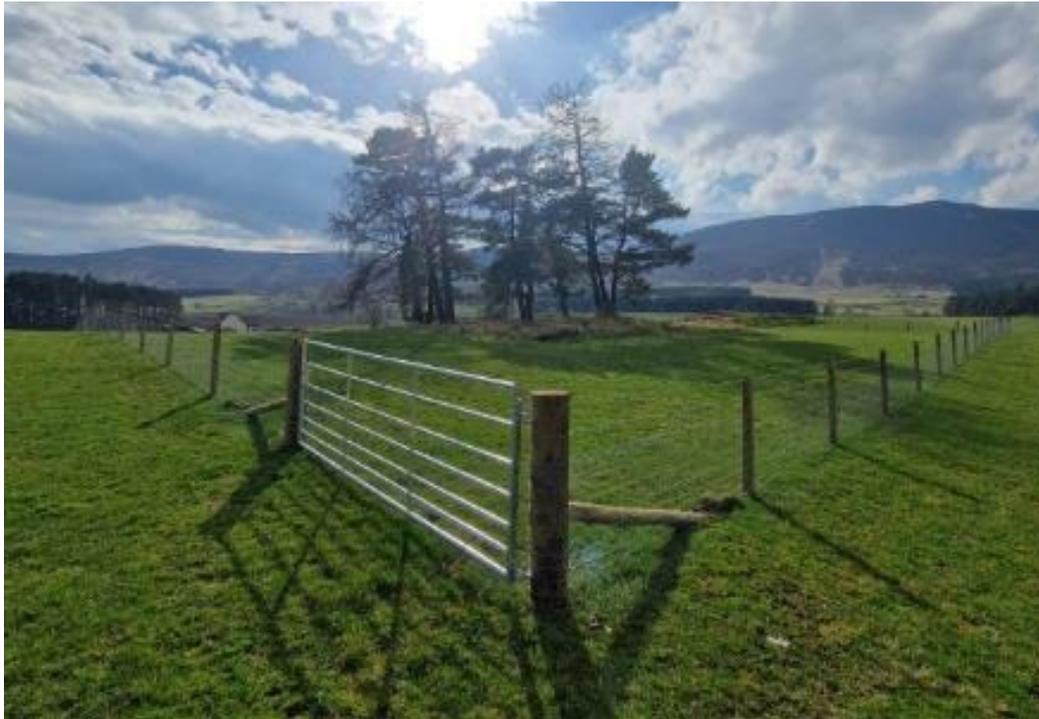
Figure 4 New rabbit proof fence installed around perimeter of the scheduled area

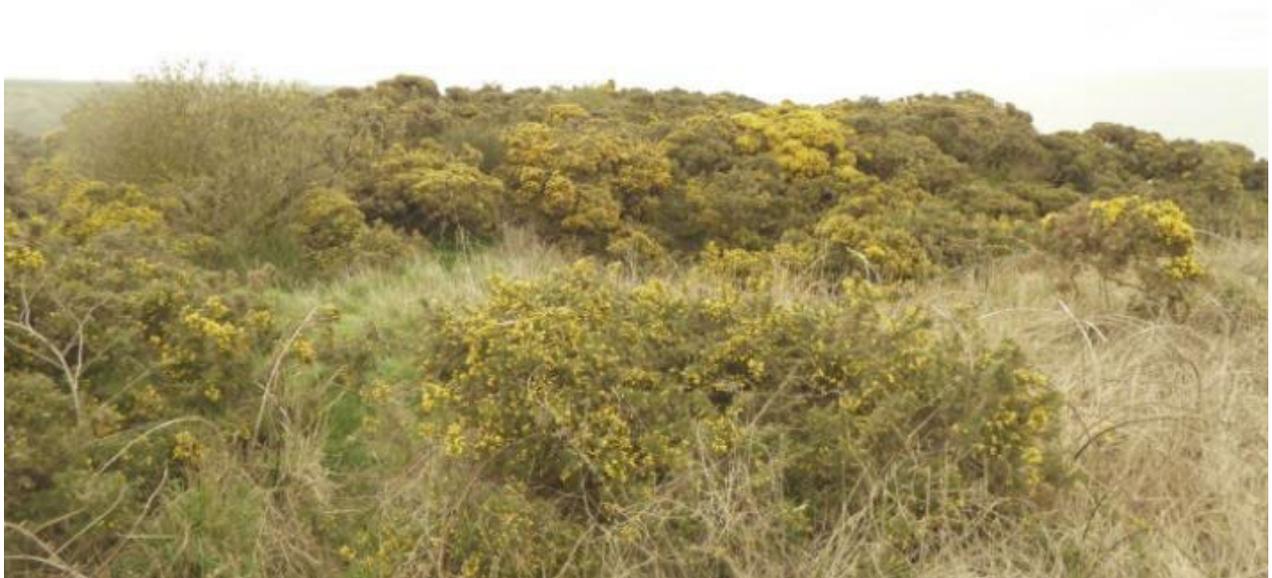
The risk of deterioration of the archaeological remains due to scrub growth has been reduced. It will also reduce the risk of rabbit burrowing under the dense cover the gorse provided. It also allows appreciation of the form of the monument.

Figure 5 View of the monument prior to works taking place, covered in gorse

Clearance of gorse, which was entirely obscuring this promontory fort.

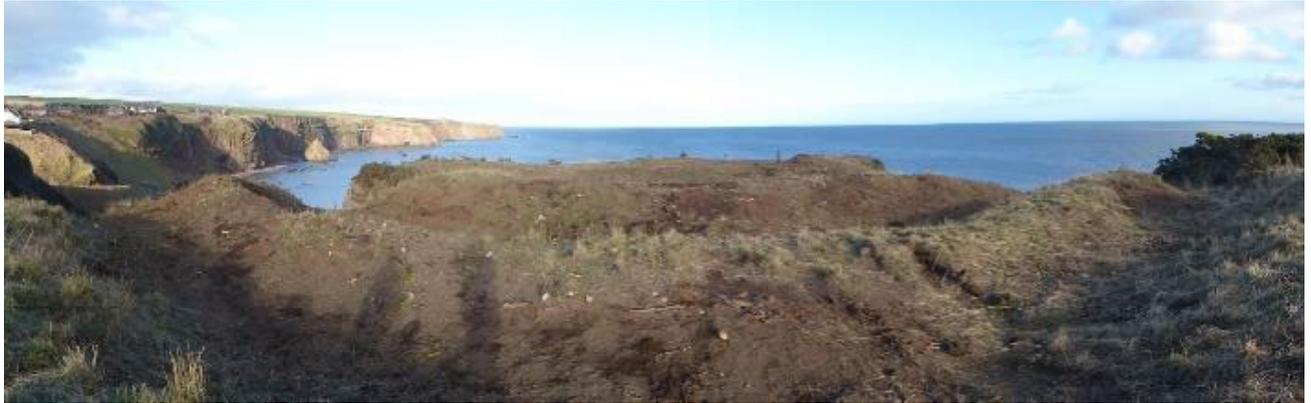
Figure 6 A view of the fort after gorse clearance

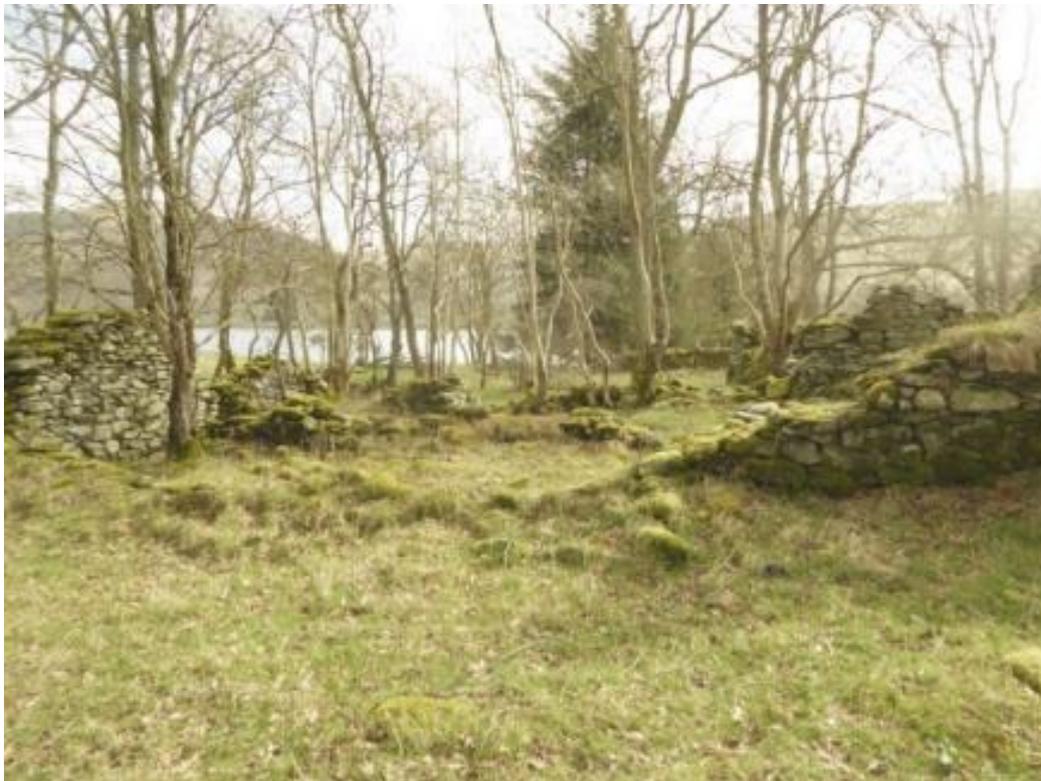
These works will reduce the risk of damage to building remains through impact damage from branches and root growth. It also allows greater appreciation of the village layout and buildings.

Figure 7 View of the building remains prior to works commencing

Overhanging branches and saplings growing on wall heads have been cut down. Stumps have been treated to prevent regrowth.

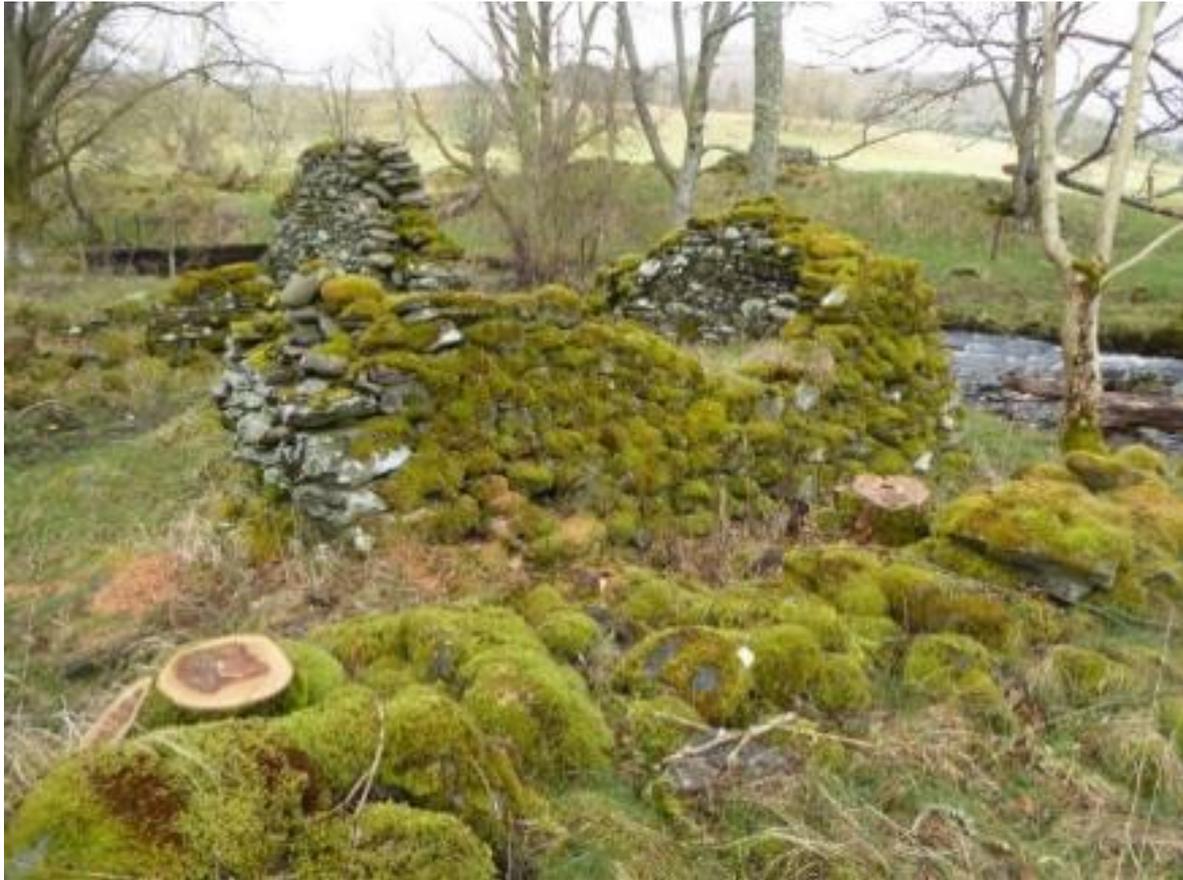
Figure 8 View of the monument with trees removed and stumps treated

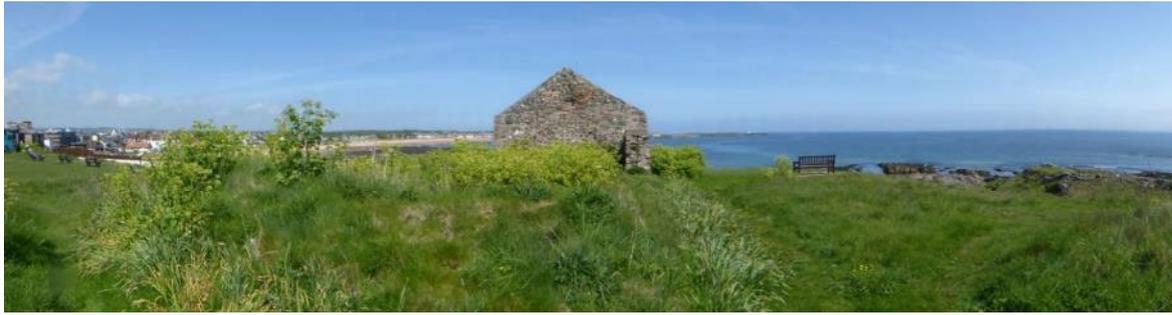
Figure 9 View of the Chapel prior to strimming – with *Smyrnium olustratum* visible in the foreground

The area around the chapel has been strimmed to help control an invasion of *Smyrniolum olustratum* (Alexanders).

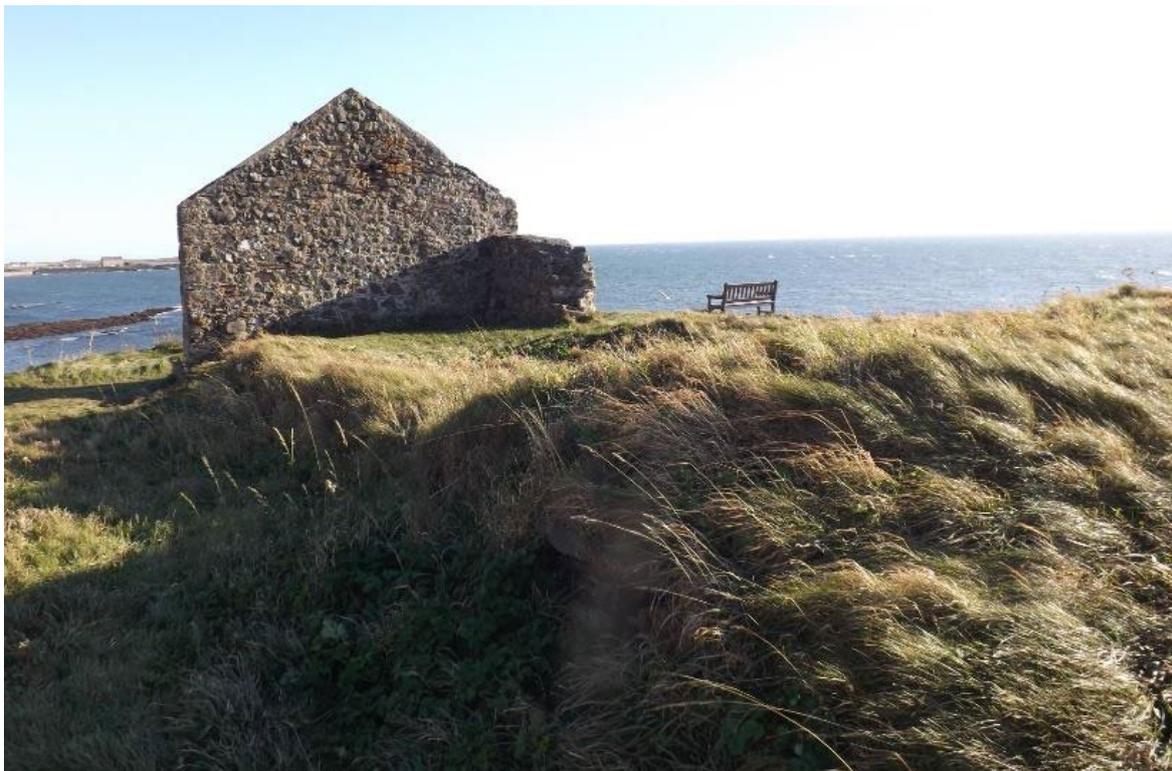
Figure 10 View of the chapel after strimming

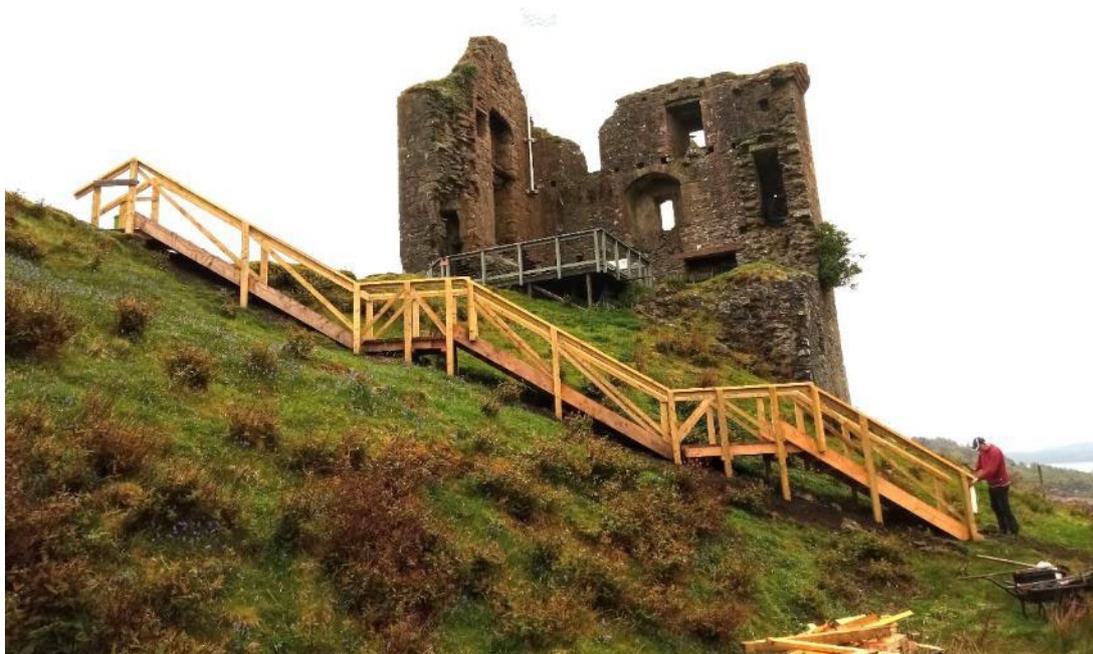
Figure 11 Maintenance of pathways and stairs to allow public access to the monument

Support for the Trust's small herd of sheep which maintains the castle under an ideal cover of short-cropped grass. The work also includes maintenance of stairs, picnic tables and shelters through weather-proofing and wood treatment, with significant in-kind contribution in volunteer hours.

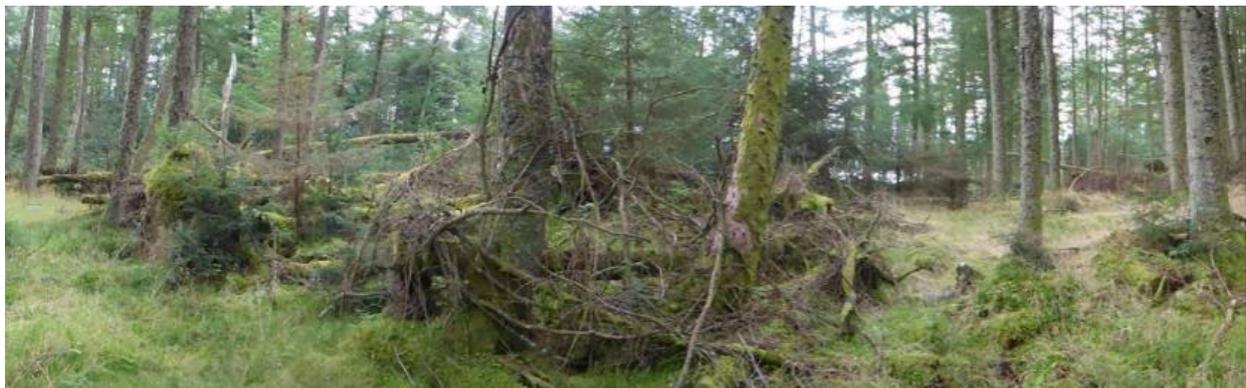
This monument has suffered significant wind blow damage over the last 10 years, with large root plates uplifted from the body of the cairn. It was at risk from further wind blow damage as many trees remained. These works have removed that risk entirely.

Figure 12 Windblown trees on the chambered cairn prior to commencement of works

All trees growing on the chambered cairn have been sectionally felled and removed to the edge of the scheduled area. In addition, a large number of wind blown trees were also cut up and disposed of. In total approx. 120 mature conifers have been removed.

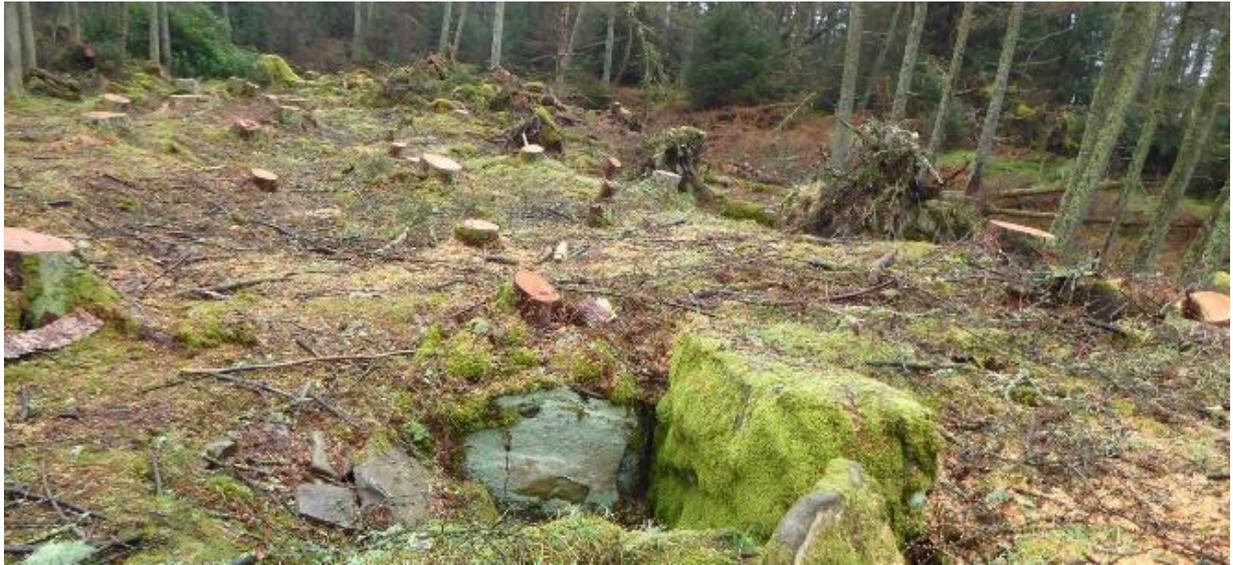
Figure 13 The chambered cairn after tree removal

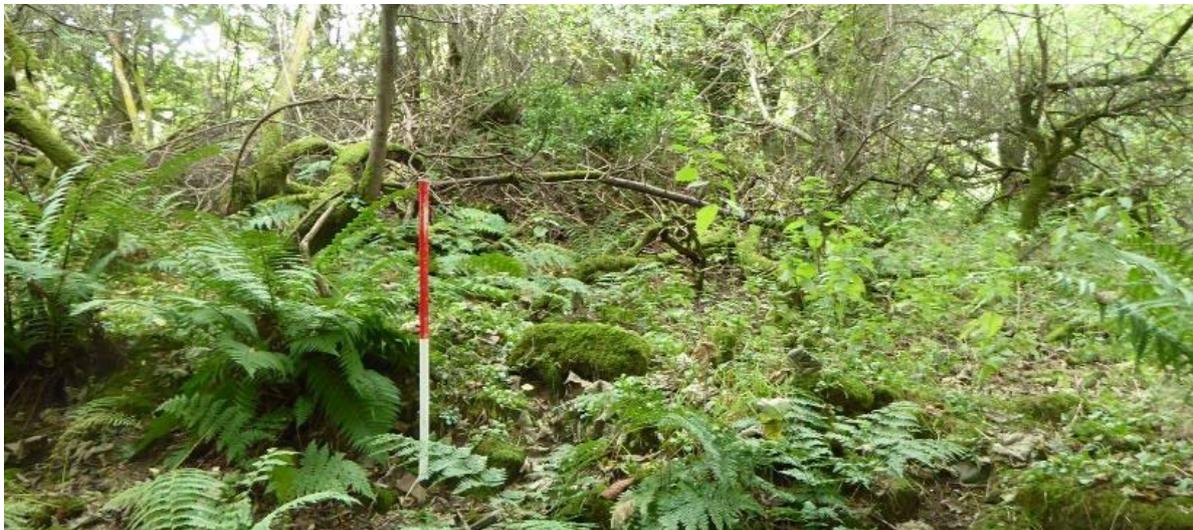
Figure 14 View of the overgrown fort prior to commencement of works

Clearance of scrub, saplings, overhanging and fallen trees from the fort. Much of the interior of the fort was obscured by a large fallen tree. All arisings have been removed from the scheduled area. Stump treatment has been carried out to prevent regrowth.

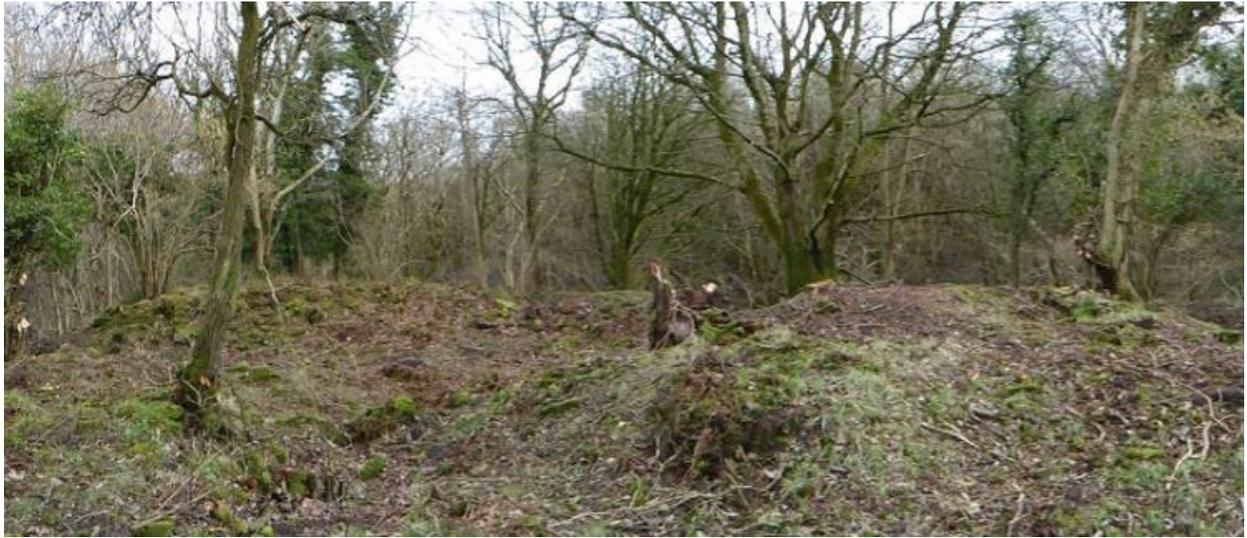
Figure 15 Remains of the fort after scrub clearance

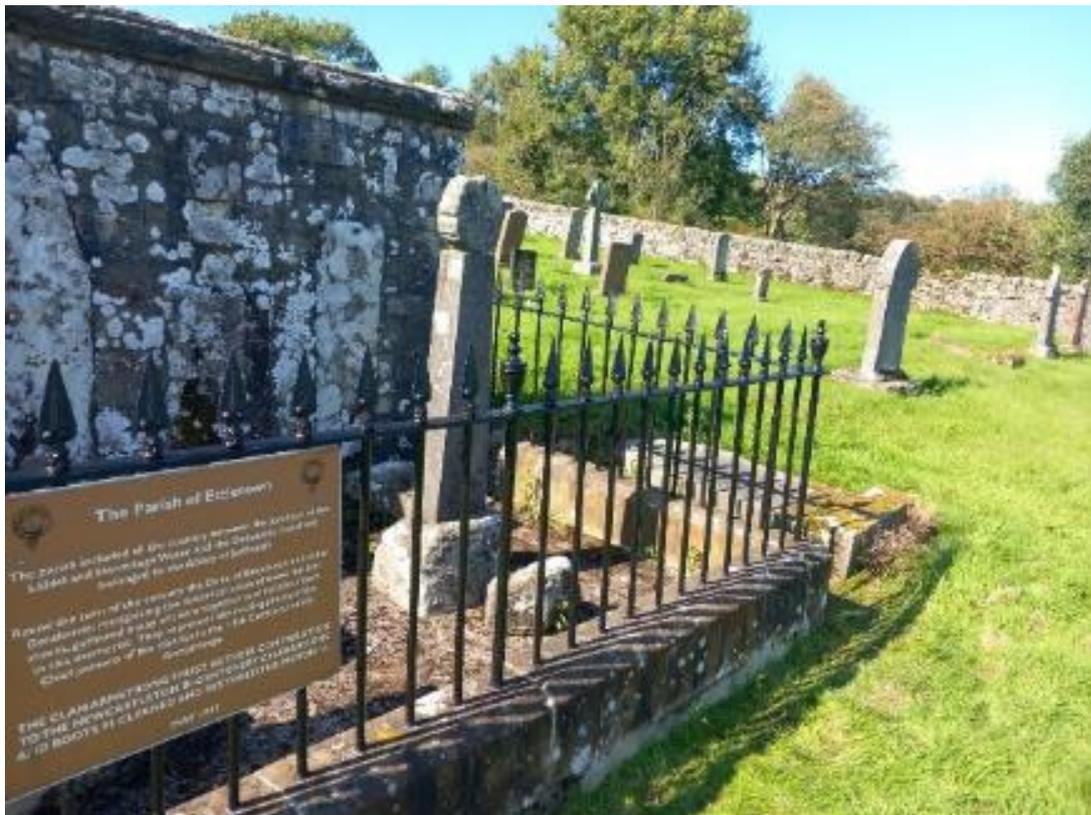
Figure 16 Completed works showing the repaired enclosure

Repointing of wall coping and repair of broken iron railings at the carved stone enclosure in Ettleton Cemetery
