HIGH-LEVEL TACTILE INSPECTIONS

SAMPLING PHASE 1
REPORT
Crichton Castle
PIC135

Title:	High-Level Tactile Sample Inspection Project Phase 1 Report PIC135 Crichton Castle
Authors:	[REDACTED]
Document created:	September 2021
Reviewed by:	[REDACTED]
Date Reviewed:	17/09/2021
Approved by:	[REDACTED]
Date of Approval:	17/09/2021
Version Number:	V0100

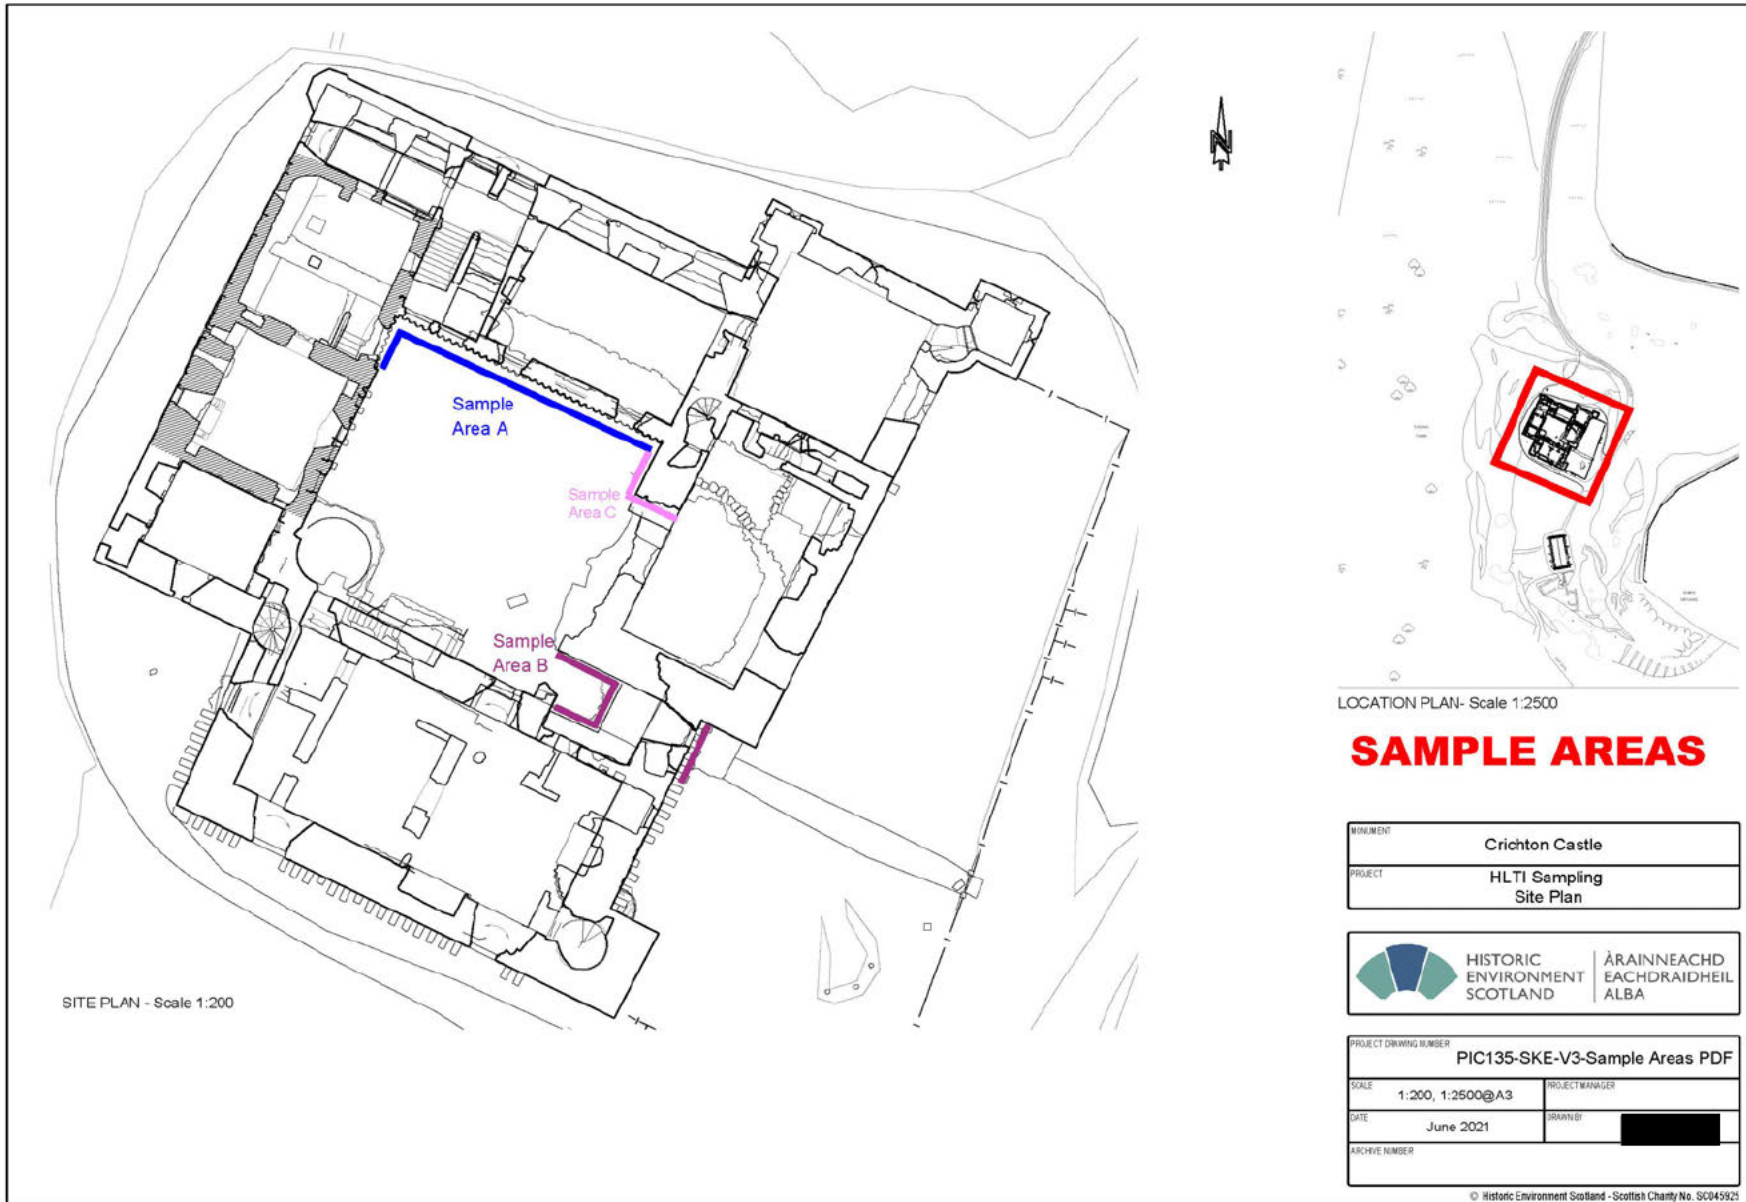
Click on link to open drawing in PDF viewer: [PIC135-SKE-V3-SampleAreas](#)

Tactile Inspection of two sample areas - the interior North wall and the Main Entrance - was carried out in accordance with HES Management of Risk Procedures as set out in High-level Fabric Policy and High level Tactile Inspection Procedures.
