Tactile safety inspection of high-level fabric

REPORT
Melrose Abbey
PIC 157

High-Level Tactile Inspection: Report - Introduction

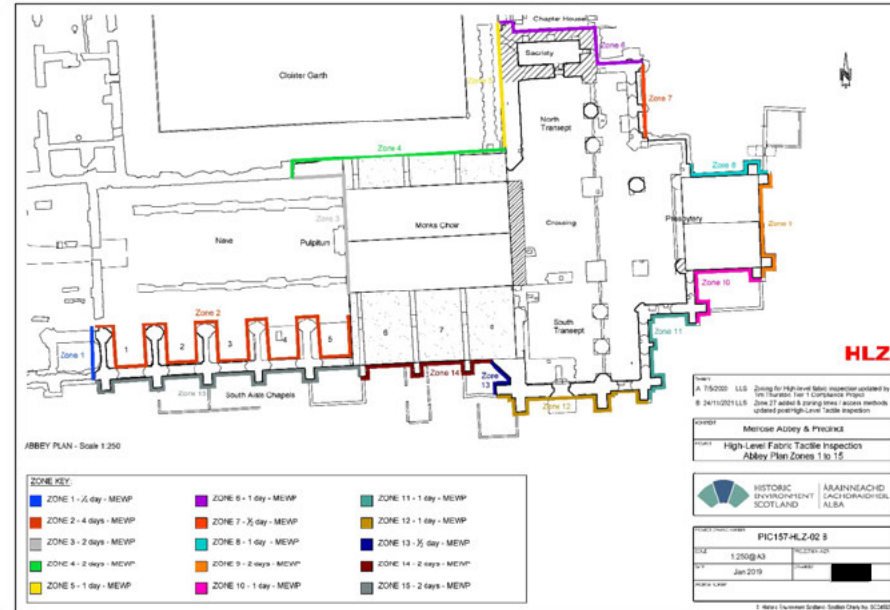
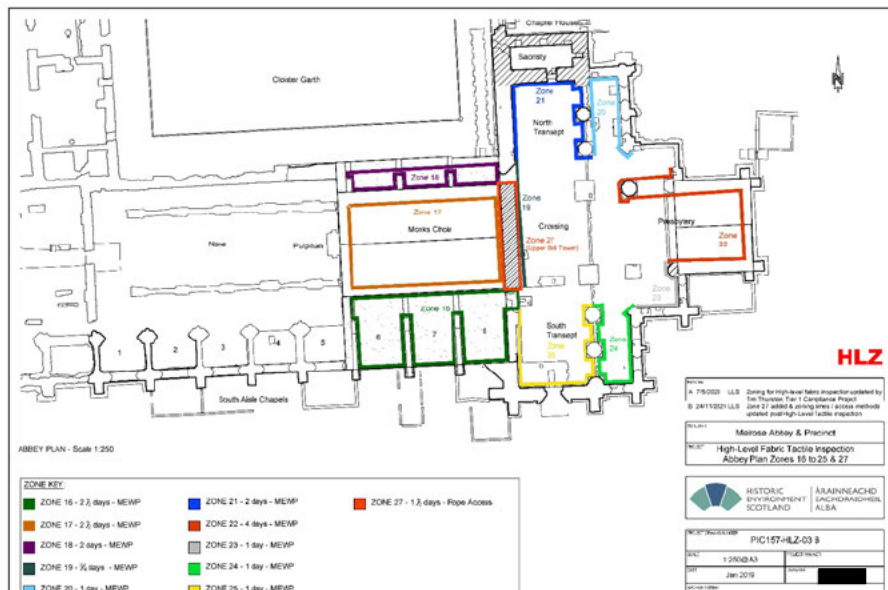
Click on link to open drawing in PDF viewer: [PIC157-HLZ-01B](#)

Zone:	Colour:	Zone Name:
1		Nave - West wall of South aisle chapels
2		South Nave Aisle Chapel Aisle 1 - 5
3		Nave - West face of pulpitum
4		Nave - North wall and clearstorey
5		North Transept - West elevation
6		North Transept - North elevation
7		North Transept - East elevation
8		Presbytery - North elevation
9		Presbytery - East elevation
10		Presbytery - South and east elevations
11		South Choir Chapel - South elevation & South transept aisle - East elevation
12		South transept - South elevation
13		South transept - West elevation
14		Nave - South nave and clearstorey
15		Nave - South Aisle chapels 1-5
16		Nave - South aisle chapels 6-8
17		Nave - Monk's Choir. Pulpitum
18		Nave - Monk's Choir. Pulpitum North
19		Tower - West wall (East face)
20		North transept aisle - West, North and East walls
21		North transept - West, North and East walls
22		Presbytery - Presbytery and North choir aisle
23		South choir chapel - South and East walls

24		South transept - East aisle
25		South transept - West, South and East walls
26		Boundary walls - West, South and East walls - Both sides
27		Upper Bell Tower (Rope Access)

High-Level Tactile Inspection: Report - High-Level Zoning Drawings

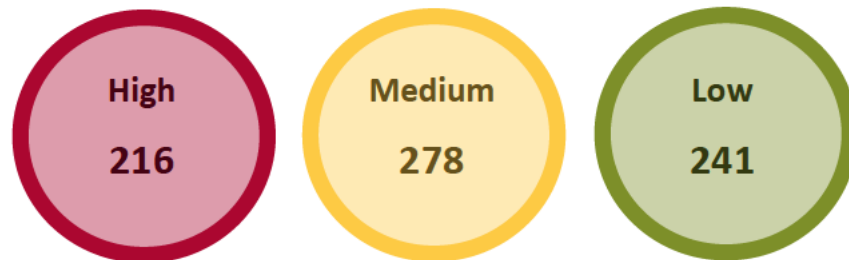
Identified Risk

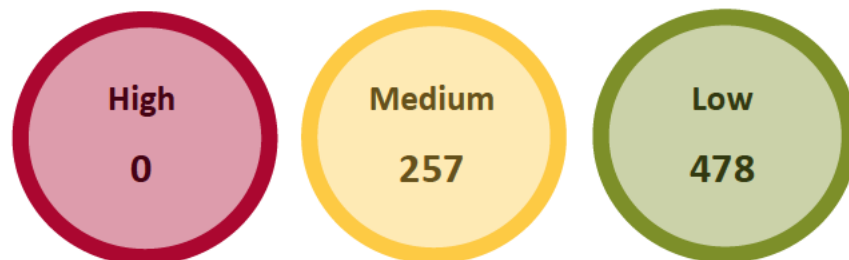
Residual Risk

After Inspection Action

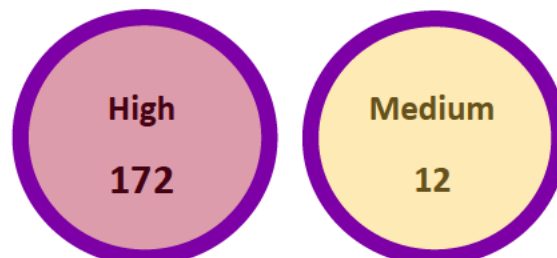
Residual Risk

Mitigated with applied Access Restriction in place
