High Level Masonry Project
Tactile safety inspection of high-level fabric

REPORT
Aberdour Castle
PIC001

Title:	Tactile safety inspection of high-level fabric Report PIC001 Aberdour Castle
Authors:

High-Level Tactile Inspection: Report - Introduction

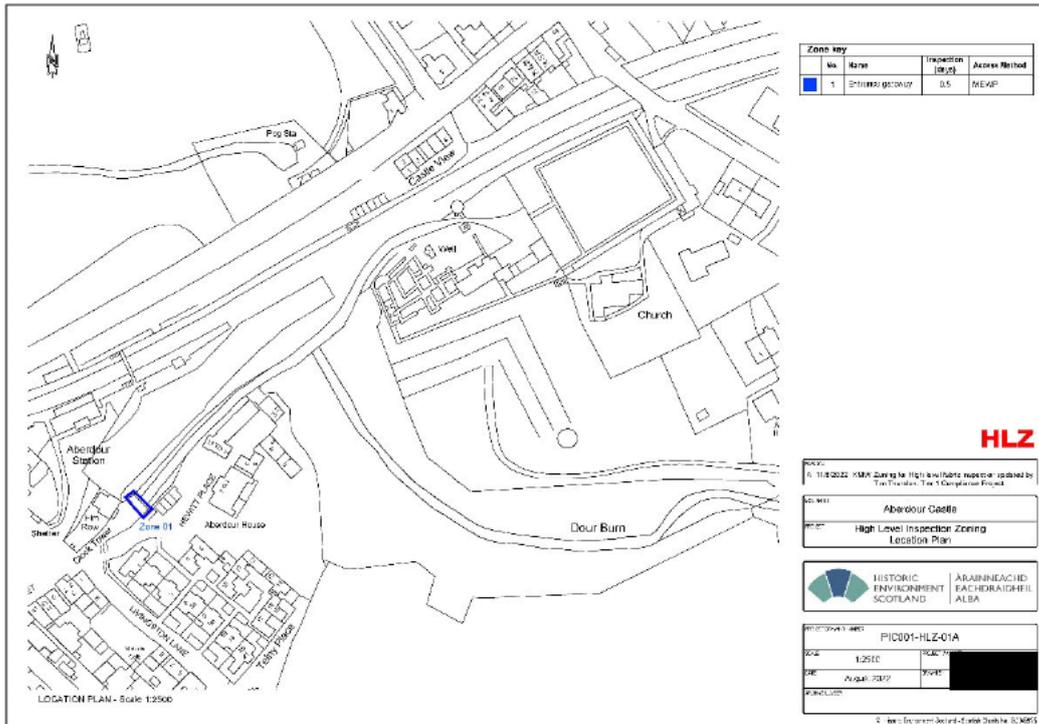
[PIC001-HLZ-01A](#)

High-Level Tactile Inspection: Report - High-Level Zoning Drawings

Zone:	Colour:	Zone Name:
1		Entrance gateway
2		Internal elevations of walls facing driveway
3		Walled garden. External West facing elevation
4		Shop and Staff area. North external walls and internal South elevation
5		East Range. North and East elevations
6		Central Range. North and East elevations
7		Tower (remains) North and East elevations
8		Tower. West and South elevations
9		Tower. Spiral stair
10		Central Range. West elevation
11		Bakehouse. External North, South, East and West elevations
12		Bakehouse. Internal North, South, East and West elevations
13		Central Range. West and South elevations
14		East Range. West and South elevations
15		Kitchen. Open chimney
16		Central Range. Internal Room. NE corner.
17		Central Range. Spiral stair. SW corner
18		Central Range. Outer chamber
19		Central Range. First floor corridor
20		Central Range. Inner Chamber
21		Upper Terrace. Wall to the east of East Range. South and West elevations

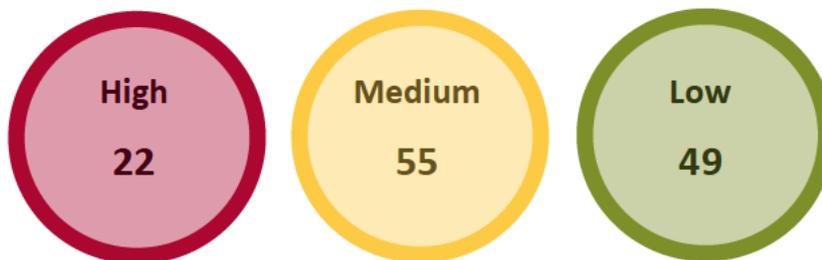
Identified Risk

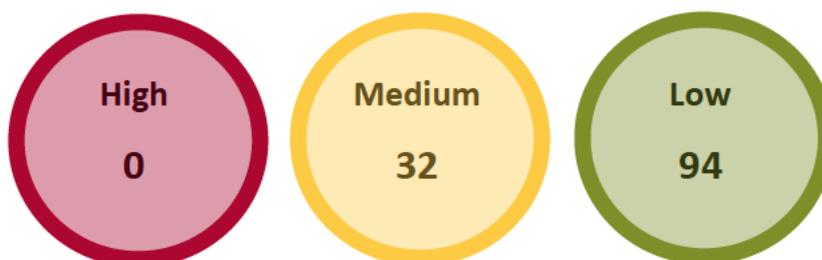
Residual Risk

After Inspection Action

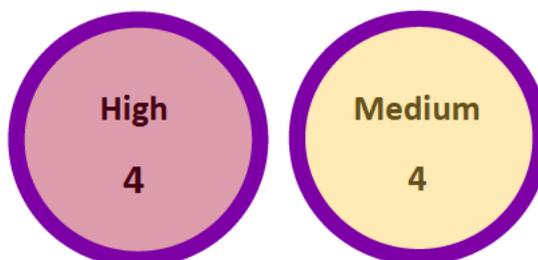
Residual Risk

Mitigated with applied Access Restriction in place

Class V Report = Fabric detached during tactile inspection	Access Restriction = Risk of fabric falling and causing harm			Monitor Observation / Plan Repairs = No immediate action
	Full site, notifiable	Partial site, notifiable	Partial site, not notifiable	
35	0	2	9	79

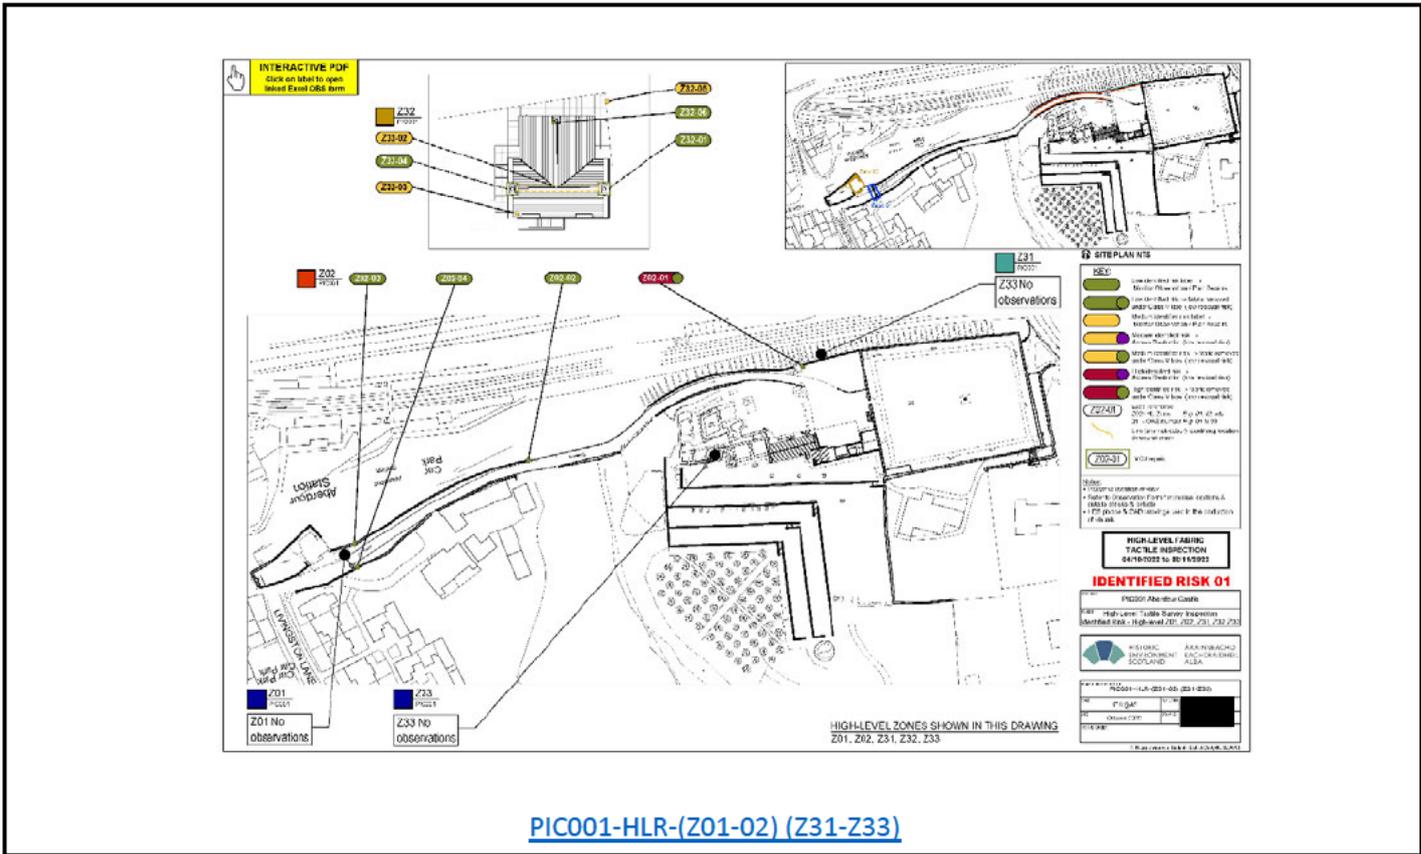
[PIC001-HLR-\(Z01-02\) \(Z31-Z33\)](#)

High-Level Tactile Inspection: Report - Risk Drawings

Click on link below image to open Interactive PDF in PDF viewer. In PDF viewer, the drawing is an interactive PDF, click on the labels to open the relevant OBS form for further information.

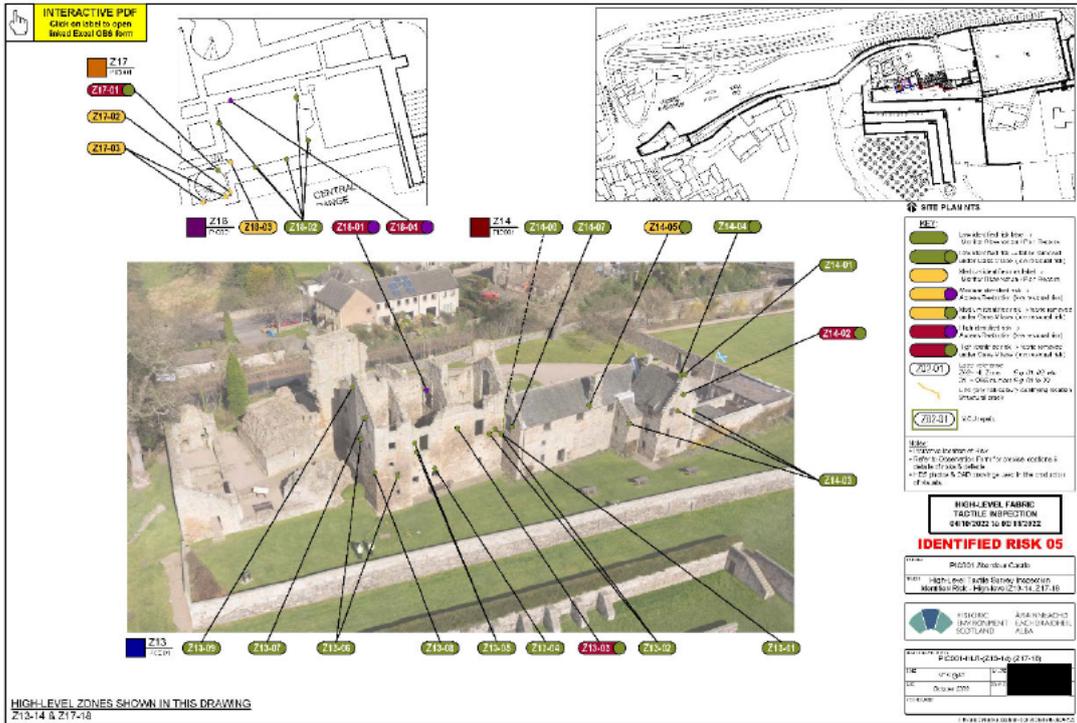
[PIC001-HLR-\(Z13-14\) \(Z17-18\)](#)

Click on link below image to open Interactive PDF in PDF viewer. In PDF viewer, the drawing is an interactive PDF, click on the labels to open the relevant OBS form for further information.

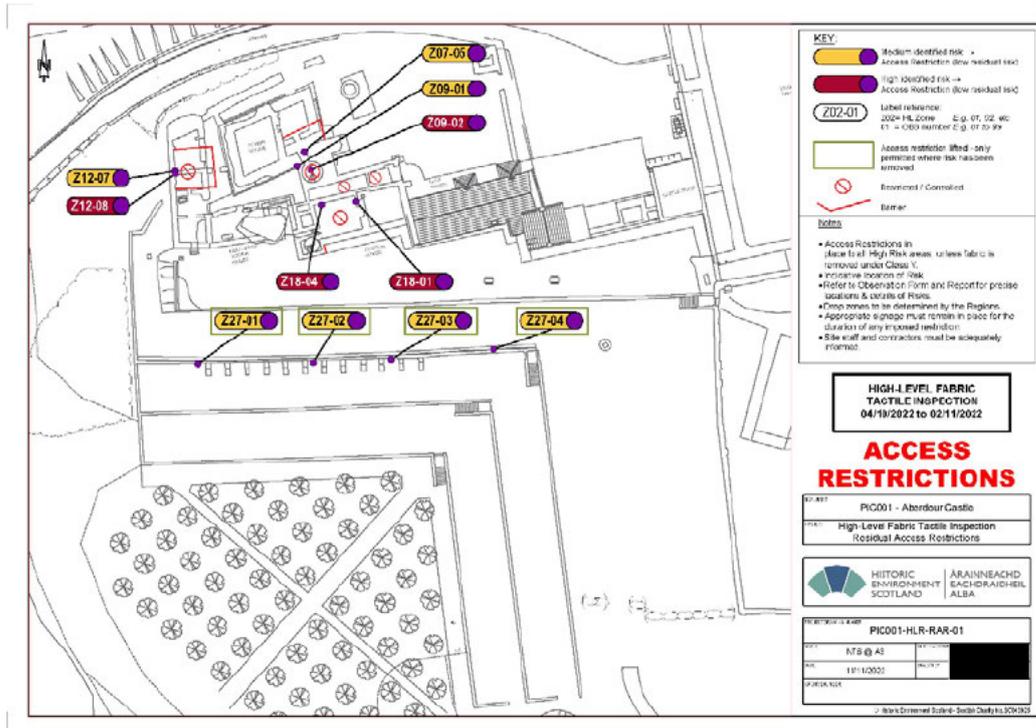
[PIC001-HLR-RAR-01](#)

Click on link below image to open drawing in PDF viewer:
