High Level Masonry Project
Tactile safety inspection of high-level fabric

REPORT
Carsluith Castle
PIC186

High-Level Tactile Inspection: Report - Introduction

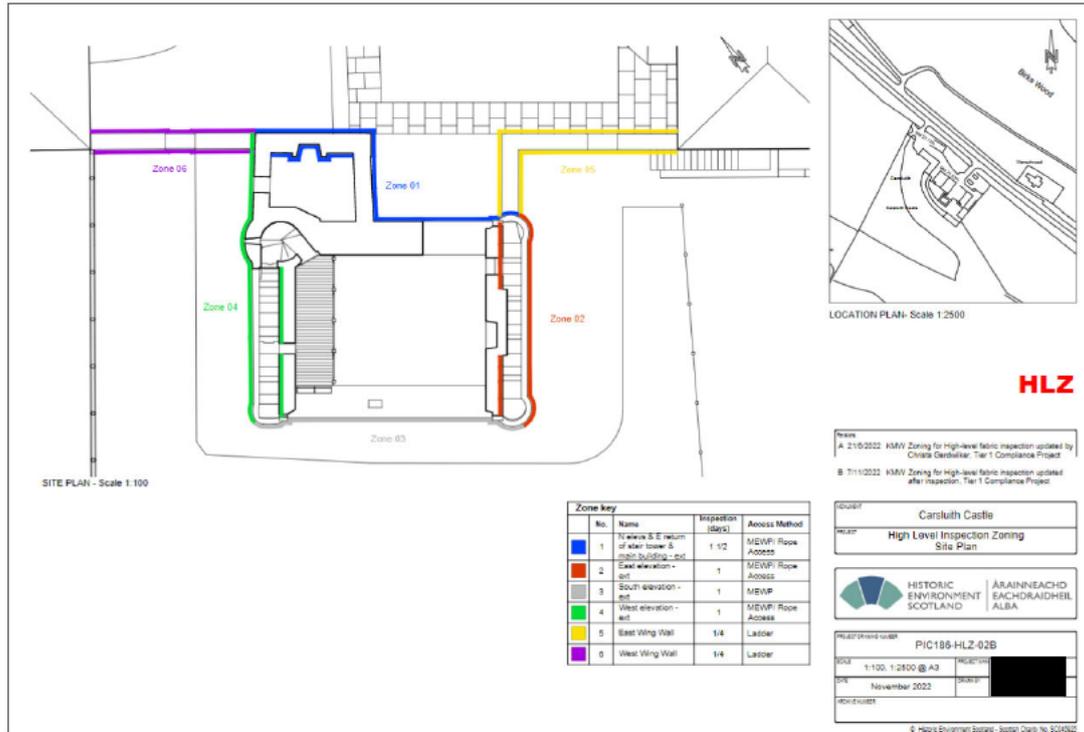
[PIC186-HLZ-02B](#)

High-Level Tactile Inspection: Report - High-Level Zoning Drawings

Click on link below image to open drawing in PDF viewer:

HL Zones:

Zone:	Colour:	Zone Name:
1

N elevs & E Return of stair tower & main building
2

East Elevation - ext
3

South Elevation - ext
4

West Elevation - ext
5

East Wing Wall
6

West Wing Wall

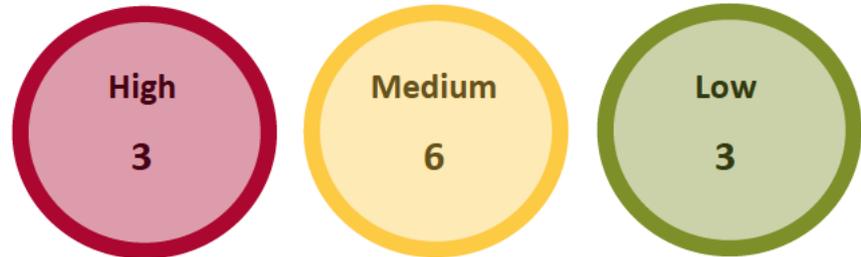
Identified Risk

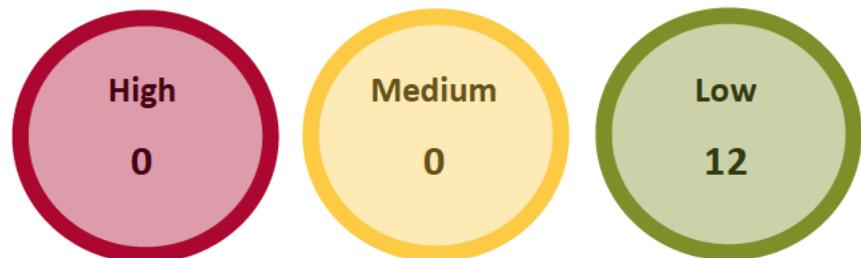
Residual Risk

After Inspection Action

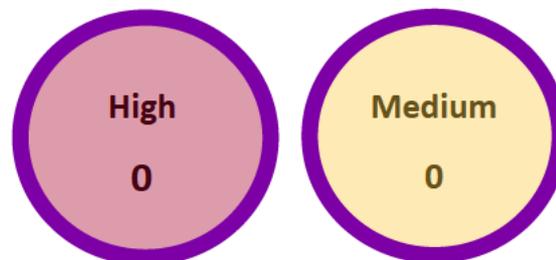
Residual Risk

Mitigated with applied Access Restriction in place

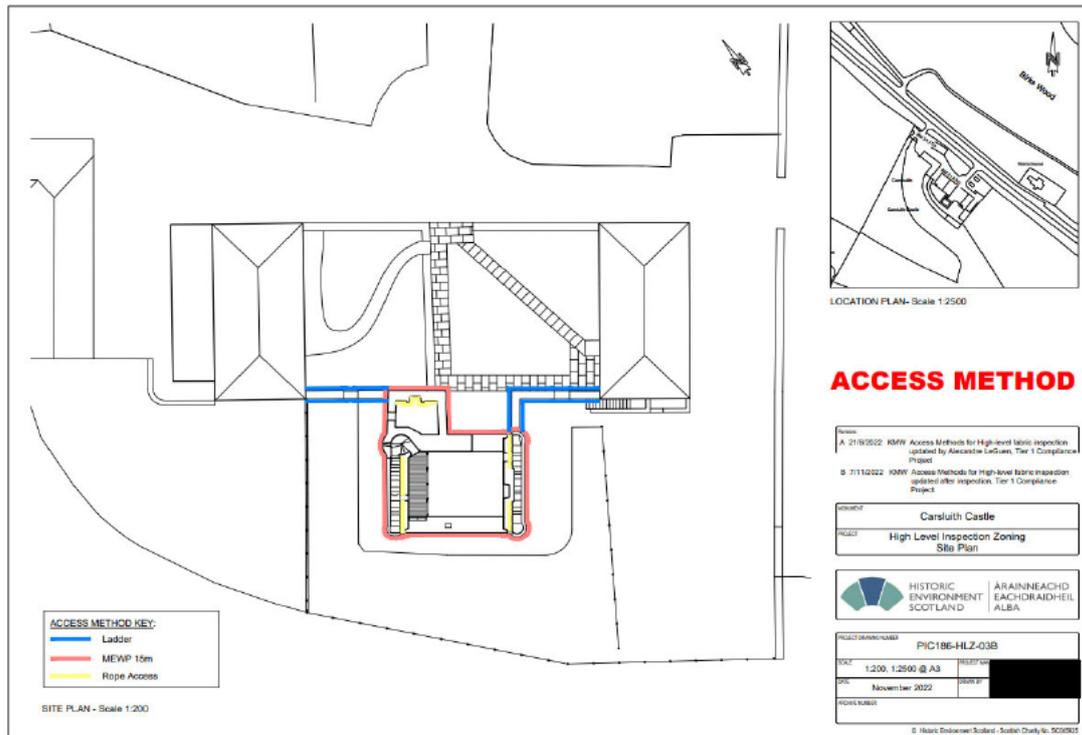
[PIC186-HLZ-03B](#)

Limitations of inspection:	Exterior of the tower house castle by MEWP, though gable wallheads required rope access due to wall width.
-----------------------------------	--

Areas not inspected:	Open interior spaces of the tower house. (NB Risk mitigation survey only)
-----------------------------	---

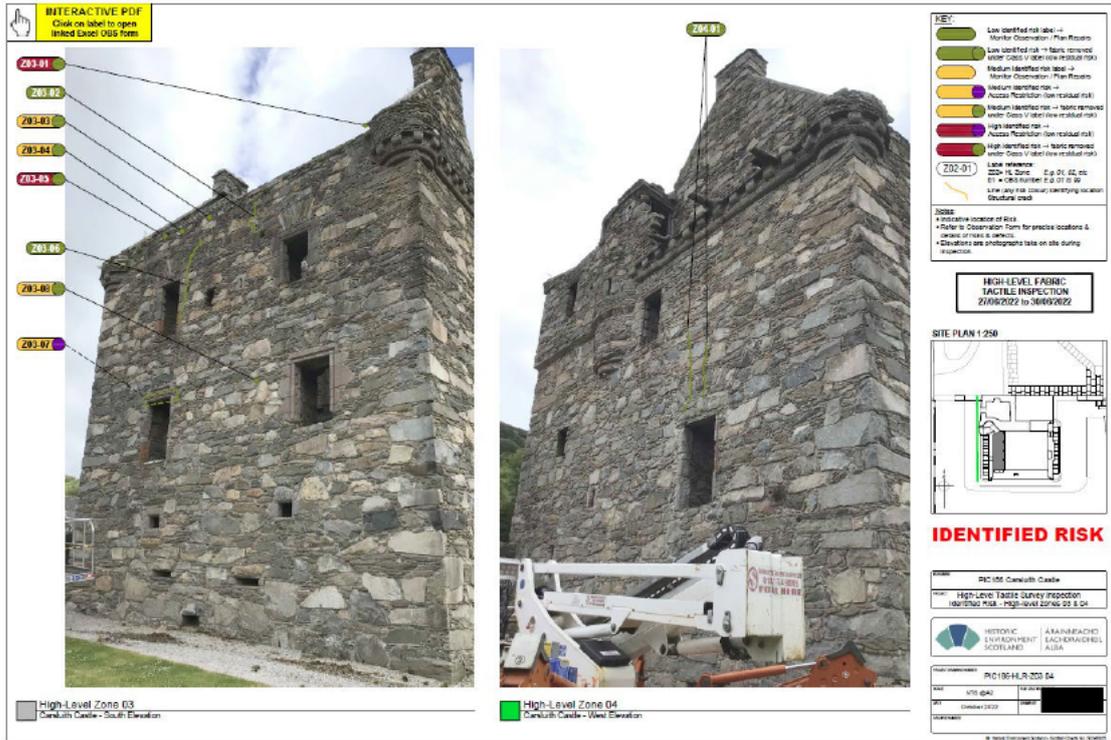
[PIC186-HLR-Z03 04](#)

Click on link below image to open Interactive PDF in PDF viewer. In PDF viewer, the drawing is an interactive PDF, click on the labels to open the relevant OBS form for further information.

- One first storey window lintel on South Elevation (Zone 3) had a shallow seating 50mm on righthand reveal. Though no movement, lintel has been propped. Note lintel is later insertion original lintel is seated above.
