HIGH-LEVEL TACTILE INSPECTIONS

SAMPLING PHASE 1
REPORT
Rothesay Castle
PIC123

MONUMENT	ROTHESAY CASTLE
PROJECT	HLTI Sampling Site Plan

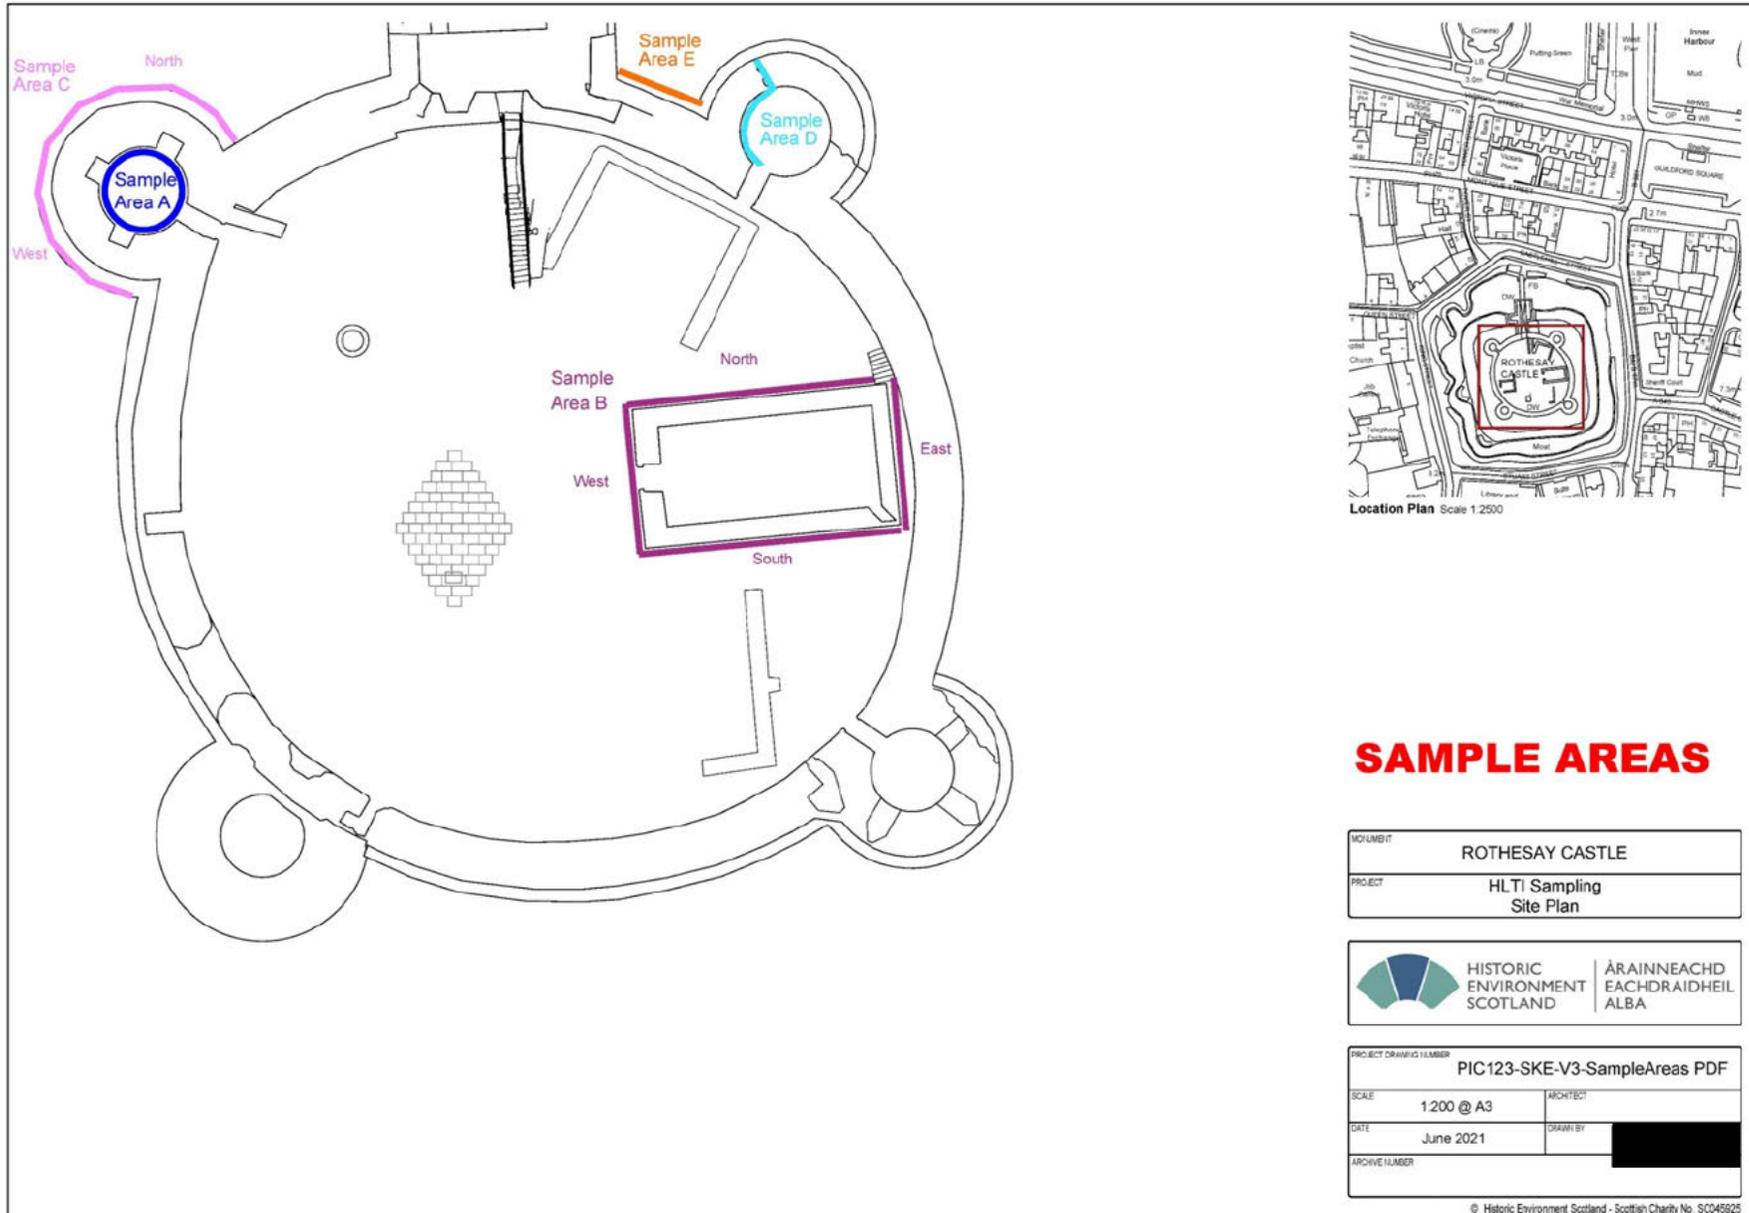
PROJECT DRAWING NUMBER	
PIC123-SKE-V3-SampleAreas PDF	
SCALE	1:200 @ A3
DATE	June 2021
ARCHITECT	
DRAWN BY	
APPROVE NUMBER

SAMPLE AREAS

Click on link to open drawing in PDF viewer: [PIC123-SKE-V3-SampleAreas](#)
